Access Compliance Report

Public Rights-of-Way

(Curb Ramps)

Intersection ID: 50595	Main Street: BENDING_BRANCH_RD	Cross Street: GRAY_WILLOW_RD	Location: N
ADA ID: 5FB2C718875B	Ramp Type: Perp	Initial Pass/Fail: Fail	Overall Compliance: No
Severity Score: 33.75			
Codes/Mitigation Info/Possible Solution		Field Measurements/Component Compliance

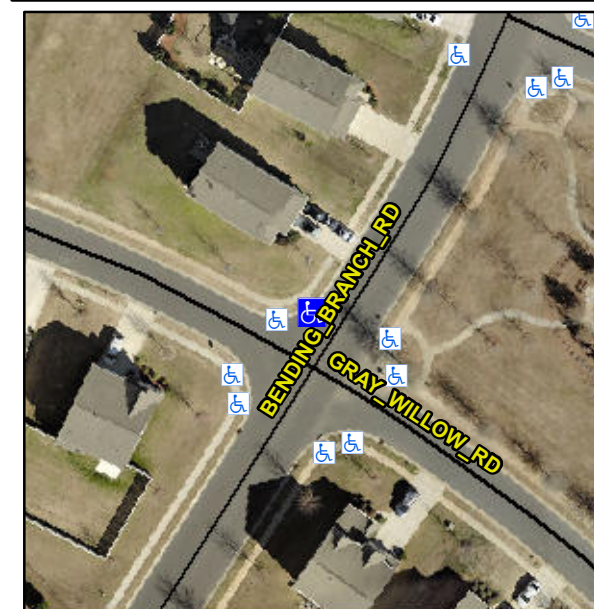
Not Found, R304.5.1, R304.2.2

Compliance	Description	Data	Compliance	Description	Data
N/A	Ramp Length (in)	49.0	No	Ramp Slope (%)	15.4
No	Ramp Width (in)	47.0	Yes	Ramp XSlope (%)	1.4
N/A	Flare Type LT	N/A	N/A	Flare Type RT	N/A
N/A	Flare Slope LT (%)	N/A	N/A	Flare Slope RT (%)	N/A
N/A	Flare Traversable LT?	N/A	N/A	Flare Traversable RT?	N/A
N/A	Landing Length (in)	N/A	N/A	DWS Provided?	N/A
N/A	Landing Width (in)	N/A	N/A	DWS Contrast?	N/A
N/A	Landing Slope (%)	N/A	N/A	DWS Length (in)	N/A
N/A	Landing X Slope (%)	N/A	N/A	DWS Full Width?	N/A
N/A	Landing Curb? (Y/N)	N/A	N/A	DWS Offset (in)	N/A
N/A	Shared Landing?	N/A			
N/A	Gutter Ponding?	N/A	N/A	Gutter Slope (%)	N/A
N/A	Gutter Lip Ht (in)	N/A	N/A	Gutter X Slope (%)	N/A
N/A	Painted X Walk1?	No	N/A	Painted X Walk2?	N/A
	X Walk 1 Direction	To SE		X Walk 2 Direction	N/A
N/A	X Walk 1 Width (in)	N/A	N/A	X Walk 2 Width (in)	N/A
	X Walk 1 Slope (%)	0.2		X Walk 2 Slope (%)	N/A
	X Walk 1 X Slope (%)	1.2		X Walk 2 X Slope (%)	N/A

N/A	Ramp inside XWalk1?	N/A	N/A	Ramp inside XWalk2?	N/A
	Road Slope (%)	N/A	N/A	Clear Space?	N/A
	Road X Slope (%)	N/A	N/A	Clear Space to XWalk (in)	N/A
N/A	Any Obstructions?	N/A	N/A	Storm Grate/Utility Hazard?	N/A
	Obstruction Type			Storm Grate/Utility Type	
		N/A			N/A
			Yes	Surface Condition? (G/P)	Good

Possible Solutions:

Remove & Replace Entire Ramp.
