Access Compliance Report Public Rights-of-Way (Curb Ramps)

Intersection ID: N/A Main Street: PERIMETER PY **Cross Street: N/A** Location: ADA ID: 5FB92B532AD9 Ramp Type: PerpDiag Initial Pass/Fail: Pass **Overall Compliance: No** Severity Score: 10.25

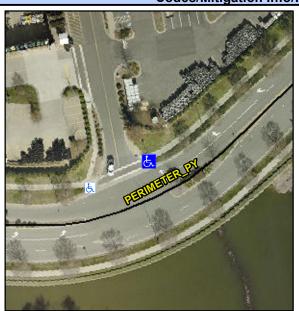
Field Measurements/Component Compliance					
Compliance Description		Data	Comp	oliance Description	Data
N/A	Ramp Length (in)	63.0	Yes	Ramp Slope (%)	7.4
Yes	Ramp Width (in)	48.0	No	Ramp XSlope (%)	2.6
N/A	Flare Type LT	Sloped	N/A	Flare Type RT	N/A
N/A	Flare Slope LT (%)	4.7	N/A	Flare Slope RT (%)	8.8
N/A	Flare Traversable LT?	No	N/A	Flare Traversable RT?	No
No	Landing Length (in)	N/A	Yes	DWS Provided?	Yes
No	Landing Width (in)	N/A	Yes	DWS Contrast?	Yes
No	Landing Slope (%)	N/A	Yes	DWS Length (in)	24.5
No	Landing X Slope (%)	N/A	Yes	DWS Full Width?	Yes
N/A	Landing Curb? (Y/N)	No	Yes	DWS Offset (in)	1.5
N/A	Shared Landing?	No			
Yes	Gutter Ponding?	No	Yes	Gutter Slope (%)	4.8
Yes	Gutter Lip Ht (in)	0.0	Yes	Gutter X Slope (%)	0.0
N/A	Painted X Walk1?	Yes	N/A	Painted X Walk2?	No
	X Walk 1 Direction	To SW		X Walk 2 Direction	To S
N/A	X Walk 1 Width (in)	71.0	N/A	X Walk 2 Width (in)	N/A
	X Walk 1 Slope (%)	0.9		X Walk 2 Slope (%)	0.5

X Walk 1 X Slope (%)	0.1		X Walk 2 X Slope (%)	1.7
Yes	Ramp inside XWalk1?	Yes	N/A	Ramp inside XWalk2?	N/A
	Road Slope (%)	1.0	N/A	Clear Space?	Yes
	Road X Slope (%)	3.8	N/A	Clear Space to XWalk (in)	N/A
Yes	Any Obstructions?	No	Yes	Storm Grate/Utility Hazard?	No
	Obstruction Type			Storm Grate/Utility Type	
		N/A			N/A
			Yes	Surface Condition? (G/P)	Good

Possible Solutions: **Remove & Replace Curb Ramp With** Two New Directional Ramps or Equivalent. Surveyor Notes: N/A PROW/ADA: Not Found, R304.5.3, R304.2.1, R304.2.2-Perp, R304.3.2-Para
