# Access Compliance Report

## Public Rights-of-Way

| Intersection ID: 14704 | Main Street: BELGRAVE_PL | Cross Street: ROMANY_RD | Location: NW |
| ADA ID: 5FBE30ECB2BA | Ramp Type: BlendTrans2 | Initial Pass/Fail: Pass | Overall Compliance: No |

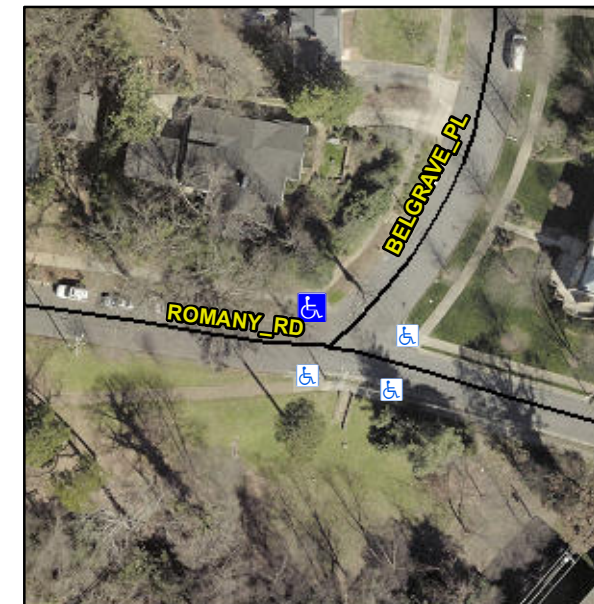
**R305.1.4, R305.2**

| Compliance | Description | Data | Compliance | Description | Data |
|---|---|---|---|---|---|
| N/A | Landing X Slope (%) | N/A | No | DWS Full Width? | No |
| N/A | Landing Curb? (Y/N) | No | No | DWS Offset (in) | 5.5 |

**Remove & Replace Detectable Warning System.**
