# Access Compliance Report

## Public Rights-of-Way

### (Curb Ramps)

Intersection ID: 10040463	Main Street: VIZCAYA_CT	Cross Street: N/A	Location: W
ADA ID: 5FBFD9F6E3E3	Ramp Type: Perp	Initial Pass/Fail: Fail	Overall Compliance: No
Codes/Mitigation Info/Possible Solution		Field Measurements/Component Compliance	
Severity Score: 12.5

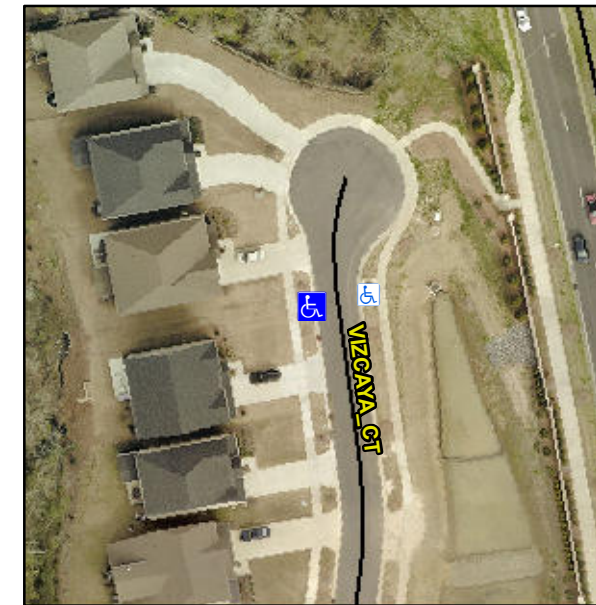
Compliance	Description	Data	Compliance	Description	Data
N/A	Ramp Length (in)	102.0	No	Ramp Slope (%)	8.6
Yes	Ramp Width (in)	48.0	Yes	Ramp XSlope (%)	1.1
N/A	Flare Type LT	N/A	N/A	Flare Type RT	N/A
N/A	Flare Slope LT (%)	N/A	N/A	Flare Slope RT (%)	N/A
N/A	Flare Traversable LT?	N/A	N/A	Flare Traversable RT?	N/A
N/A	Landing Length (in)	N/A	N/A	DWS Provided?	N/A
N/A	Landing Width (in)	N/A	N/A	DWS Contrast?	N/A
N/A	Landing Slope (%)	N/A	N/A	DWS Length (in)	N/A
N/A	Landing X Slope (%)	N/A	N/A	DWS Full Width?	N/A
N/A	Landing Curb? (Y/N)	N/A	N/A	DWS Offset (in)	N/A
N/A	Shared Landing?	N/A			
N/A	Gutter Ponding?	N/A	N/A	Gutter Slope (%)	N/A
N/A	Gutter Lip Ht (in)	N/A	N/A	Gutter X Slope (%)	N/A
N/A	Painted X Walk1?	No	N/A	Painted X Walk2?	N/A
	X Walk 1 Direction	To E		X Walk 2 Direction	N/A
N/A	X Walk 1 Width (in)	N/A	N/A	X Walk 2 Width (in)	N/A
	X Walk 1 Slope (%)	3.5		X Walk 2 Slope (%)	N/A
	X Walk 1 X Slope (%)	0.0		X Walk 2 X Slope (%)	N/A

N/A	Ramp inside XWalk1?	N/A	N/A	Ramp inside XWalk2?	N/A
	Road Slope (%)	N/A	N/A	Clear Space?	N/A
	Road X Slope (%)	N/A	N/A	Clear Space to XWalk (in)	N/A
N/A	Any Obstructions?	N/A	N/A	Storm Grate/Utility Hazard?	N/A
	Obstruction Type			Storm Grate/Utility Type	
		N/A			N/A
			Yes	Surface Condition? (G/P)	Good

Possible Solutions:

**Remove & Replace Entire Ramp.**

**R304.2.2**

Total Cost: \$ 1850.00
