Access Compliance Report Public Rights-of-Way (Curb Ramps)

Intersection ID: 5646 Main Street: MCCULLOUGH_DR Cross Street: COLLINS-AIKMAN_DR Location: W

ADA ID: 5FC30951D4B8 Ramp Type: PerpDiag Initial Pass/Fail: Fail Overall Compliance: No Severity Score: 21.25

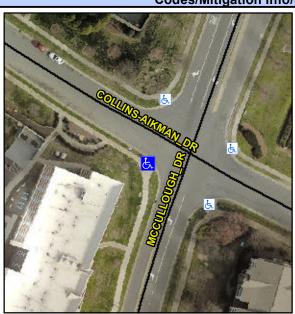
Not Found, R304.5.1, R304.2.2

Field Measurements/Component Compliance						
Compliance Description			Data	Compliance Description		Data
	N/A	Ramp Length (in)	81.0	No	Ramp Slope (%)	8.5
ı	No	Ramp Width (in)	45.5	Yes	Ramp XSlope (%)	1.6
ı	N/A	Flare Type LT	N/A	N/A	Flare Type RT	N/A
ı	N/A	Flare Slope LT (%)	N/A	N/A	Flare Slope RT (%)	N/A

Remove & Replace Curb Ramp With Two New Directional Ramps or Equivalent.
