## Access Compliance Report Public Rights-of-Way (Curb Ramps)

Intersection ID: 16802 Main Street: IDLEBROOK\_DR Cross Street: IDLEWILD\_RD Location: NE

ADA ID: 5FD5E09DC364 Ramp Type: PerpDiag Initial Pass/Fail: Fail Overall Compliance: No Severity Score: 37.5

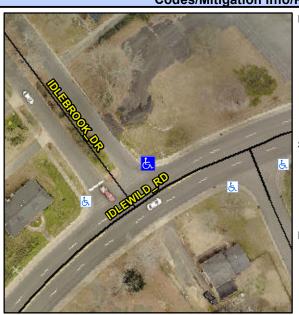
Compliance Description Data Compliance Description Data					
			Data		Description	Data
	N/A	Ramp Length (in)	58.0	No 	Ramp Slope (%)	13.1
	Yes	Ramp Width (in)	48.0	No	Ramp XSlope (%)	6.7
	N/A	Flare Type LT	N/A	N/A	Flare Type RT	N/A
	N/A	Flare Slope LT (%)	N/A	N/A	Flare Slope RT (%)	N/A
	N/A	Flare Traversable LT?	N/A	N/A	Flare Traversable RT?	N/A
	N/A	Landing Length (in)	N/A	N/A	DWS Provided?	N/A
	N/A	Landing Width (in)	N/A	N/A	DWS Contrast?	N/A
	N/A	Landing Slope (%)	N/A	N/A	DWS Length (in)	N/A
	N/A	Landing X Slope (%)	N/A	N/A	DWS Full Width?	N/A
	N/A	Landing Curb? (Y/N)	N/A	N/A	DWS Offset (in)	N/A
	N/A	Shared Landing?	N/A			
	N/A	Gutter Ponding?	N/A	N/A	Gutter Slope (%)	N/A
	N/A	Gutter Lip Ht (in)	N/A	N/A	Gutter X Slope (%)	N/A
	N/A	Painted X Walk1?	No	N/A	Painted X Walk2?	No
		X Walk 1 Direction	To SW		X Walk 2 Direction	To SE
	N/A	X Walk 1 Width (in)	N/A	N/A	X Walk 2 Width (in)	N/A
		X Walk 1 Slope (%)	1.2		X Walk 2 Slope (%)	11.1

X Walk 1 X Slope (%)	5.6		X Walk 2 X Slope (%)	5.7
	N/A	Ramp inside XWalk1?	N/A	N/A	Ramp inside XWalk2?	N/A
		Road Slope (%)	7.7	N/A	Clear Space?	N/A
		Road X Slope (%)	3.0	N/A	Clear Space to XWalk (in)	N/A
	N/A	Any Obstructions?	N/A	N/A	Storm Grate/Utility Hazard?	N/A
		Obstruction Type			Storm Grate/Utility Type	
			N/A			N/A
				Yes	Surface Condition? (G/P)	Good

Remove & Replace Curb Ramp With Two New Directional Ramps or Equivalent.

R304.2.2, R304.5.3
