# Access Compliance Report

## Public Rights-of-Way

### (Curb Ramps)

Intersection ID: 15195	Main Street: ALBEMARLE_RD	Cross Street: FARM_POND_LN	Location: S
ADA ID: 5FE2AA58DEC5	Ramp Type: MedianPerp	Initial Pass/Fail: Fail	Overall Compliance: No
Severity Score: 8.75			
Codes/Mitigation Info/Possible Solution		Field Measurements/Component Compliance

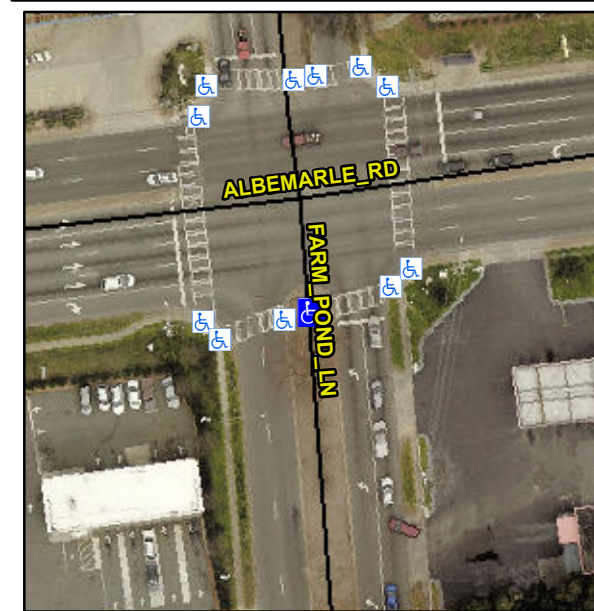
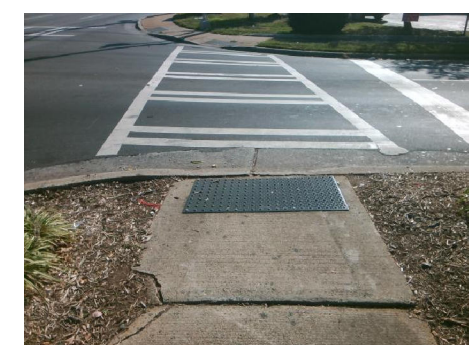
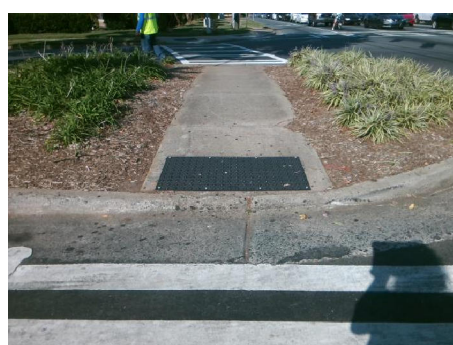
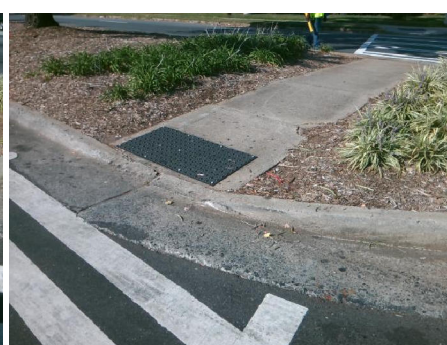
**Not Found, R304.5.1**

Compliance	Description	Data	Compliance	Description	Data
N/A	Ramp Length (in)	60.5	Yes	Ramp Slope (%)	6.0
No	Ramp Width (in)	42.0	Yes	Ramp XSlope (%)	0.7
N/A	Flare Type LT	N/A	N/A	Flare Type RT	N/A
N/A	Flare Slope LT (%)	N/A	N/A	Flare Slope RT (%)	N/A
N/A	Flare Traversable LT?	N/A	N/A	Flare Traversable RT?	N/A
N/A	Landing Length (in)	N/A	N/A	DWS Provided?	N/A
N/A	Landing Width (in)	N/A	N/A	DWS Contrast?	N/A
N/A	Landing Slope (%)	N/A	N/A	DWS Length (in)	N/A
N/A	Landing X Slope (%)	N/A	N/A	DWS Full Width?	N/A
N/A	Landing Curb? (Y/N)	N/A	N/A	DWS Offset (in)	N/A
N/A	Shared Landing?	N/A			
N/A	Gutter Ponding?	N/A	N/A	Gutter Slope (%)	N/A
N/A	Gutter Lip Ht (in)	N/A	N/A	Gutter X Slope (%)	N/A
N/A	Painted X Walk1?	Yes	N/A	Painted X Walk2?	N/A
	X Walk 1 Direction	To W		X Walk 2 Direction	N/A
N/A	X Walk 1 Width (in)	111.0	N/A	X Walk 2 Width (in)	N/A
	X Walk 1 Slope (%)	0.9		X Walk 2 Slope (%)	N/A
	X Walk 1 X Slope (%)	1.4		X Walk 2 X Slope (%)	N/A

N/A	Ramp inside XWalk1?	Yes	N/A	Ramp inside XWalk2?	N/A
	Road Slope (%)	N/A	N/A	Clear Space?	N/A
	Road X Slope (%)	N/A	N/A	Clear Space to XWalk (in)	N/A
N/A	Any Obstructions?	N/A	N/A	Storm Grate/Utility Hazard?	N/A
	Obstruction Type			Storm Grate/Utility Type	
		N/A			N/A
			Yes	Surface Condition? (G/P)	Good

**Remove & Replace Entire Ramp.**
