Access Compliance Report

Public Rights-of-Way

(Curb Ramps)

Intersection ID: 48373	Main Street: WHEATFIELD_RD	Cross Street: GARDEN_VIEW_DR	Location: W
ADA ID: 5FE964322665	Ramp Type: BlendTrans1	Initial Pass/Fail: Pass	Overall Compliance: No
		Severity Score: 5.25

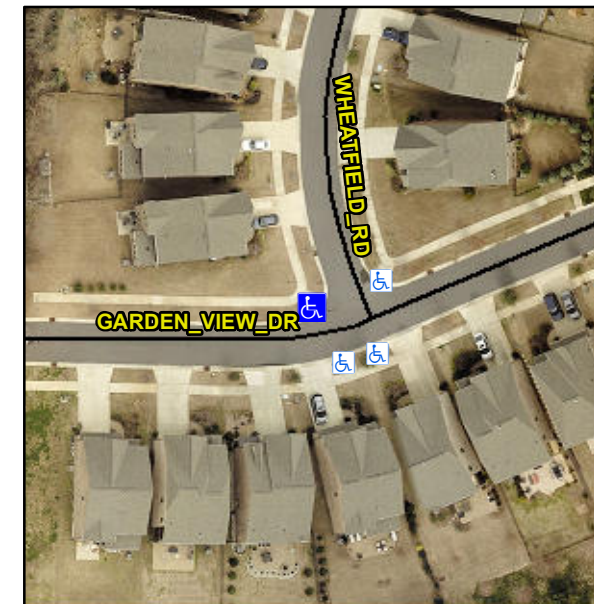
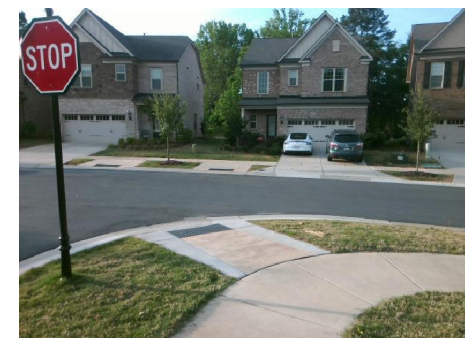
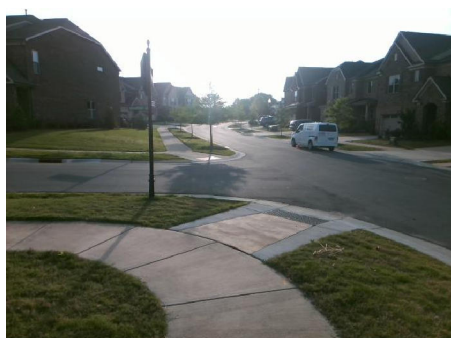
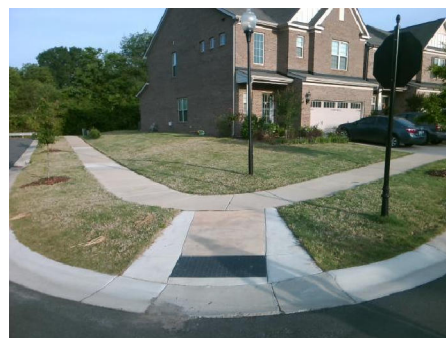
DWS OS SLOPE 21.0%

Not Found, R304.5.3, R305.2, R304.5.4

Compliance	Description	Data	Compliance	Description	Data
N/A	Ramp Length (in)	115.0	Yes	BlendTrans Slope (%)	4.9
Yes	Ramp Width (in)	48.0	No	BlendTrans XSlope (%)	4.3
N/A	Flare Type LT	Sloped	N/A	Flare Type RT	Sloped
N/A	Flare Slope LT (%)	0.0	N/A	Flare Slope RT (%)	11.2
N/A	Flare Traversable LT?	No	N/A	Flare Traversable RT?	No
Yes	Landing Length (in)	60.0	Yes	DWS Provided?	Yes
Yes	Landing Width (in)	48.0	Yes	DWS Contrast?	Yes
Yes	Landing Slope (%)	1.5	Yes	DWS Length (in)	24.0
No	Landing X Slope (%)	5.7	Yes	DWS Full Width?	Yes
N/A	Landing Curb? (Y/N)	No	No	DWS Offset (in)	6.0
N/A	Shared Landing?	No			
Yes	Gutter Ponding?	No	No	Gutter Slope (%)	6.0
Yes	Gutter Lip Ht (in)	0.0	No	Gutter X Slope (%)	2.9
N/A	Painted X Walk1?	No	N/A	Painted X Walk2?	No
	X Walk 1 Direction	To SE		X Walk 2 Direction	To NE
	X Walk 1 Width (in)	N/A		X Walk 2 Width (in)	N/A
	X Walk 1 Slope (%)	2.7		X Walk 2 Slope (%)	3.4
	X Walk 1 X Slope (%)	1.4		X Walk 2 X Slope (%)	1.7

N/A	Ramp inside XWalk1?	N/A	N/A	Ramp inside XWalk2?	N/A
	Road Slope (%)	1.8		Clear Space?	Yes
	Road X Slope (%)	2.0	N/A	Clear Space to XWalk (in)	N/A
Yes	Any Obstructions?	No	Yes	Storm Grate/Utility Hazard?	No
	Obstruction Type			Storm Grate/Utility Type	
		N/A			N/A
			Yes	Surface Condition? (G/P)	Good
			No	Curb Slope (%)	5.2

Remove & Replace Curb Ramp With Two New Directional Ramps or Equivalent. Remove & Replace Gutter.
