Access Compliance Report

Public Rights-of-Way

(Curb Ramps)

Intersection ID: 12199	Main Street: E_5TH_ST	Cross Street: N_TRYON_ST	Location: S
ADA ID: 5FF1B16833B5	Ramp Type: PerpDiag	Initial Pass/Fail: Fail	Overall Compliance: No
Severity Score: 12.5			
Codes/Mitigation Info/Possible Solution		Field Measurements/Component Compliance

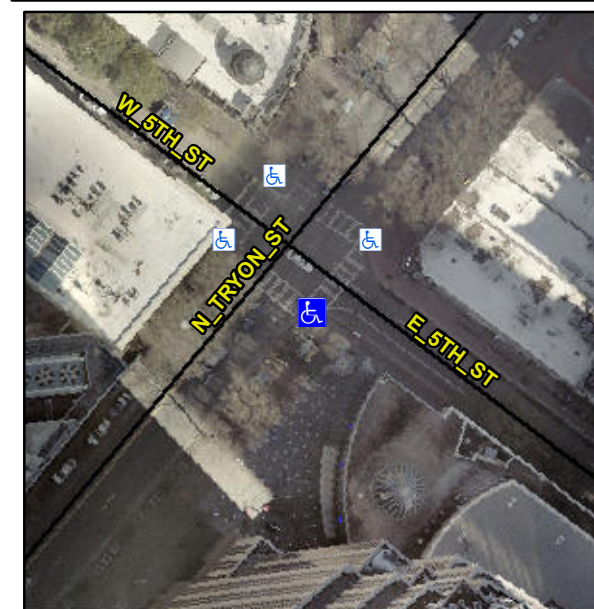
Compliance	Description	Data	Compliance	Description	Data
N/A	Ramp Length (in)	96.0	No	Ramp Slope (%)	8.4
Yes	Ramp Width (in)	66.0	Yes	Ramp XSlope (%)	0.4
N/A	Flare Type LT	N/A	N/A	Flare Type RT	N/A
N/A	Flare Slope LT (%)	N/A	N/A	Flare Slope RT (%)	N/A
N/A	Flare Traversable LT?	N/A	N/A	Flare Traversable RT?	N/A
N/A	Landing Length (in)	N/A	N/A	DWS Provided?	N/A
N/A	Landing Width (in)	N/A	N/A	DWS Contrast?	N/A
N/A	Landing Slope (%)	N/A	N/A	DWS Length (in)	N/A
N/A	Landing X Slope (%)	N/A	N/A	DWS Full Width?	N/A
N/A	Landing Curb? (Y/N)	N/A	N/A	DWS Offset (in)	N/A
N/A	Shared Landing?	N/A			
N/A	Gutter Ponding?	N/A	N/A	Gutter Slope (%)	N/A
N/A	Gutter Lip Ht (in)	N/A	N/A	Gutter X Slope (%)	N/A
N/A	Painted X Walk1?	Yes	N/A	Painted X Walk2?	Yes
	X Walk 1 Direction	To NE		X Walk 2 Direction	To NW
N/A	X Walk 1 Width (in)	111.0	N/A	X Walk 2 Width (in)	119.0
	X Walk 1 Slope (%)	1.8		X Walk 2 Slope (%)	1.2
	X Walk 1 X Slope (%)	1.6		X Walk 2 X Slope (%)	1.9

N/A	Ramp inside XWalk1?	Yes	N/A	Ramp inside XWalk2?	Yes
	Road Slope (%)	2.6	N/A	Clear Space?	N/A
	Road X Slope (%)	1.7	N/A	Clear Space to XWalk (in)	N/A
N/A	Any Obstructions?	N/A	N/A	Storm Grate/Utility Hazard?	N/A
	Obstruction Type			Storm Grate/Utility Type	
		N/A			N/A
		Yes		Surface Condition? (G/P)	Good

Possible Solutions:

Remove & Replace Curb Ramp With Two New Directional Ramps or Equivalent.

R304.2.2

\$ 3200.00
