Access Compliance Report

Public Rights-of-Way

(Curb Ramps)

Intersection ID: 14294	Main Street: EAST_BV	Cross Street: EUCLID_AV	Location: NE
ADA ID: 600D19551557	Ramp Type: Directional1	Initial Pass/Fail: Fail	Overall Compliance: No
Severity Score: 37.5			
Codes/Mitigation Info/Possible Solution		Field Measurements/Component Compliance

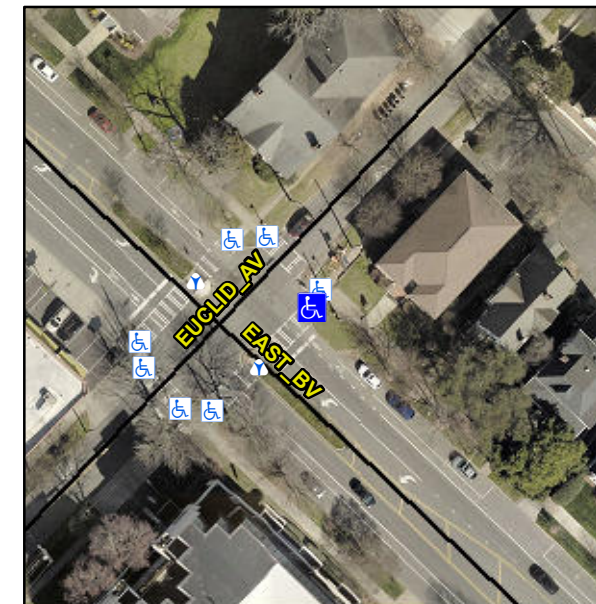
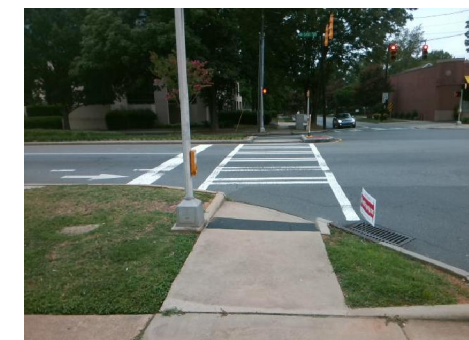
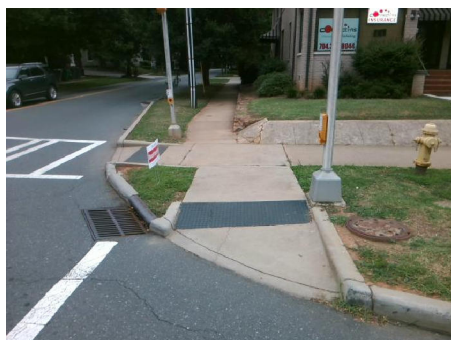
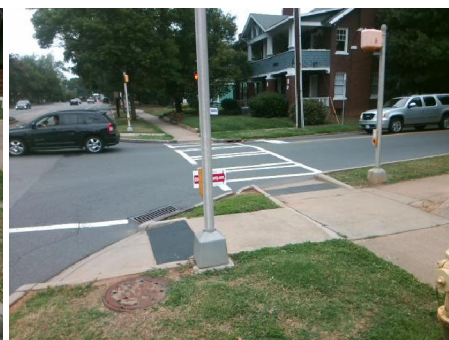
R304.2.2, R304.5.3

Compliance	Description	Data	Compliance	Description	Data
N/A	Ramp Length (in)	24.5	N/A	Grade Break?	N/A
Yes	Ramp Width (in)	64.0	N/A	Grade Break Slope (%)	0.0
No	Ramp Slope (%)	14.4	N/A	Grade Break XSlope (%)	0.0
No	Ramp XSlope (%)	5.6			
N/A	Flare Type LT	N/A	N/A	Flare Type RT	N/A
N/A	Flare Slope LT (%)	N/A	N/A	Flare Slope RT (%)	0.0
N/A	Flare Traversable LT?	N/A	N/A	Flare Traversable RT?	N/A
N/A	Landing Length (in)	0.0	N/A	DWS Provided?	N/A
N/A	Landing Width (in)	0.0	N/A	DWS Contrast?	N/A
N/A	Landing Slope (%)	0.0	N/A	DWS Length (in)	N/A
N/A	Landing X Slope (%)	0.0	N/A	DWS Full Width?	N/A
N/A	Landing Curb? (Y/N)	N/A	N/A	DWS Offset LT (in)	N/A
N/A	Shared Landing?	N/A	N/A	DWS Offset RT (in)	N/A
N/A	Gutter Ponding?	0.0	N/A	Gutter Slope (%)	N/A
N/A	Gutter Lip Ht (in)	0.0	N/A	Gutter X Slope (%)	N/A
N/A	Painted X Walk1?	Yes		Road Slope (%)	3.9
	X Walk 1 Direction	To SW		Road X Slope (%)	0.3
	X Walk 1 Width (in)	110.0		Clear Space?	N/A

X Walk 1 Slope (%)	3.9	N/A	Clear Space to XWalk (in)	N/A
	X Walk 1 X Slope (%)	0.3	N/A	Storm Grate/Utility Hazard?	N/A
N/A	Ramp inside XWalk1?	Yes		Storm Grate/Utility Type	
N/A	Any Obstructions?	N/A			N/A
	Obstruction Type		Yes	Surface Condition? (G/P)	Good
			N/A	Curb Slope (%)	10.8

Remove & Replace Entire Ramp.
