Access Compliance Report

Public Rights-of-Way

(Curb Ramps)

Intersection ID: 10038698	Main Street: STANCILL_PL	Cross Street: N/A	Location: W
ADA ID: 600EED3637DF	Ramp Type: Para	Initial Pass/Fail: Fail	Overall Compliance: No
Codes/Mitigation Info/Possible Solution			Severity Score: 25
Field Measurements/Component Compliance

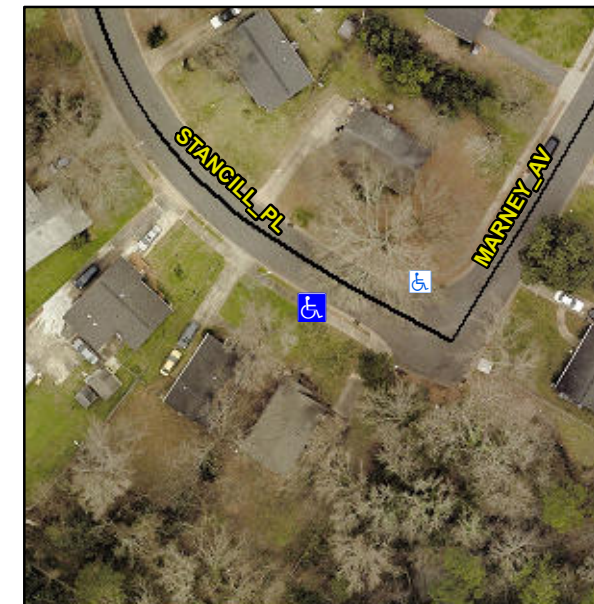
LT RP < 5%

R304.3.2

Compliance	Description	Data	Compliance	Description	Data
N/A	Ramp Length LT (in)	26.0	N/A	Ramp Length RT (in)	27.0
Yes	Ramp Width LT (in)	60.0	Yes	Ramp Width RT (in)	60.0
Yes	Ramp Slope LT (%)	0.3	No	Ramp Slope RT (%)	12.7
Yes	Ramp XSlope LT (%)	1.4	Yes	Ramp XSlope RT (%)	2.0
N/A	Landing Length (in)	N/A	N/A	DWS Provided?	N/A
N/A	Landing Width (in)	N/A	N/A	DWS Contrast?	N/A
N/A	Landing Slope (%)	N/A	N/A	DWS Length (in)	N/A
N/A	Landing X Slope (%)	N/A	N/A	DWS Full Width?	N/A
N/A	Landing Curb? (Y/N)	N/A	N/A	DWS Offset (in)	N/A
N/A	Shared Landing?	N/A			
N/A	Gutter Ponding?	N/A	N/A	Gutter Slope (%)	N/A
N/A	Gutter Lip Ht (in)	N/A	N/A	Gutter X Slope (%)	N/A
N/A	Painted X Walk1?	No	N/A	Painted X Walk2?	N/A
	X Walk 1 Direction	To NE		X Walk 2 Direction	N/A
N/A	X Walk 1 Width (in)	N/A	N/A	X Walk 2 Width (in)	N/A
	X Walk 1 Slope (%)	7.6		X Walk 2 Slope (%)	N/A
	X Walk 1 X Slope (%)	3.2		X Walk 2 X Slope (%)	N/A
N/A	Ramp inside XWalk1?	N/A	N/A	Ramp inside XWalk2?	N/A

Road Slope (%)	N/A	N/A	Clear Space?	N/A
	Road X Slope (%)	N/A	N/A	Clear Space to XWalk (in)	N/A
N/A	Any Obstructions?	N/A	N/A	Storm Grate/Utility Hazard?	N/A
	Obstruction Type			Storm Grate/Utility Type	
		N/A			N/A
			Yes	Surface Condition? (G/P)	Good
			N/A	Curb Slope (%)	20.5

Possible Solutions:

Remove & Replace Entire Ramp.
