Access Compliance Report

Public Rights-of-Way

(Curb Ramps)

Intersection ID: 19405	Main Street: DUNFRIES_RD	Cross Street: MARGARET_WALLACE_RD	Location: SW
ADA ID: 6016A0CE60C1	Ramp Type: PerpDiag	Initial Pass/Fail: Fail	Overall Compliance: No
Severity Score: 25			
Codes/Mitigation Info/Possible Solution		Field Measurements/Component Compliance

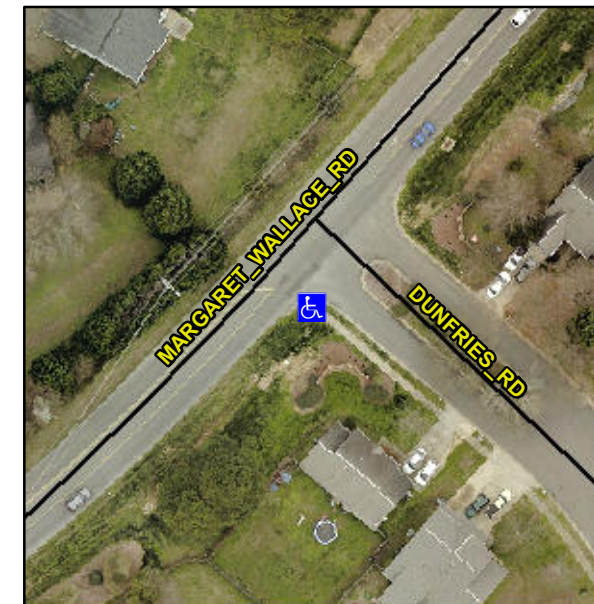
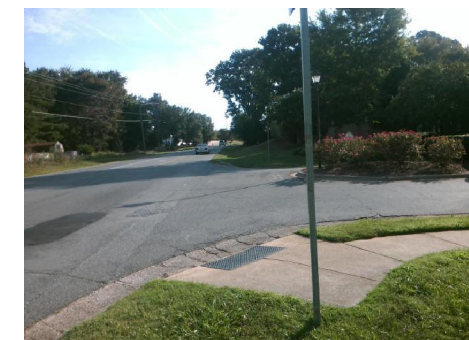
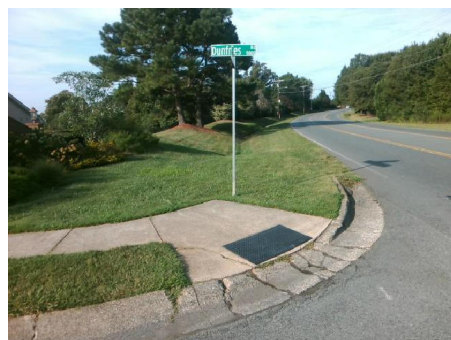
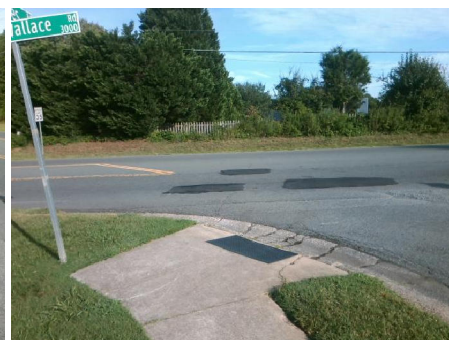
Compliance	Description	Data	Compliance	Description	Data
N/A	Ramp Length (in)	48.0	No	Ramp Slope (%)	12.3
Yes	Ramp Width (in)	48.0	Yes	Ramp XSlope (%)	1.2
N/A	Flare Type LT	N/A	N/A	Flare Type RT	N/A
N/A	Flare Slope LT (%)	N/A	N/A	Flare Slope RT (%)	N/A
N/A	Flare Traversable LT?	N/A	N/A	Flare Traversable RT?	N/A
N/A	Landing Length (in)	N/A	N/A	DWS Provided?	N/A
N/A	Landing Width (in)	N/A	N/A	DWS Contrast?	N/A
N/A	Landing Slope (%)	N/A	N/A	DWS Length (in)	N/A
N/A	Landing X Slope (%)	N/A	N/A	DWS Full Width?	N/A
N/A	Landing Curb? (Y/N)	N/A	N/A	DWS Offset (in)	N/A
N/A	Shared Landing?	N/A			
N/A	Gutter Ponding?	N/A	N/A	Gutter Slope (%)	N/A
N/A	Gutter Lip Ht (in)	N/A	N/A	Gutter X Slope (%)	N/A
N/A	Painted X Walk1?	No	N/A	Painted X Walk2?	No
	X Walk 1 Direction	To NE		X Walk 2 Direction	To NW
N/A	X Walk 1 Width (in)	N/A	N/A	X Walk 2 Width (in)	N/A
	X Walk 1 Slope (%)	4.6		X Walk 2 Slope (%)	5.8
	X Walk 1 X Slope (%)	3.5		X Walk 2 X Slope (%)	0.7

N/A	Ramp inside XWalk1?	N/A	N/A	Ramp inside XWalk2?	N/A
	Road Slope (%)	0.9	N/A	Clear Space?	N/A
	Road X Slope (%)	6.1	N/A	Clear Space to XWalk (in)	N/A
N/A	Any Obstructions?	N/A	N/A	Storm Grate/Utility Hazard?	N/A
	Obstruction Type			Storm Grate/Utility Type	
		N/A			N/A
		Yes		Surface Condition? (G/P)	Good

Possible Solutions:

Remove & Replace Curb Ramp With Two New Directional Ramps or Equivalent.
