# Access Compliance Report

## Public Rights-of-Way

### (Curb Ramps)

Intersection ID: 25775	Main Street: CARMEL_RD	Cross Street: PINEVILLE-MATTHEWS_RD	Location: NE
ADA ID: 601FD44280D6	Ramp Type: IslandPerp	Initial Pass/Fail: Fail	Overall Compliance: No
Severity Score: 42.5			
Codes/Mitigation Info/Possible Solution		Field Measurements/Component Compliance

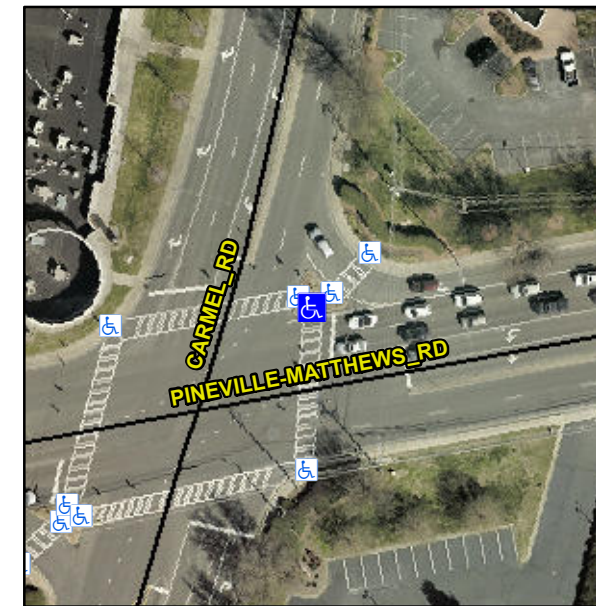
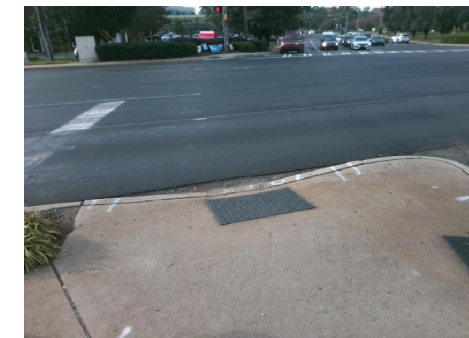
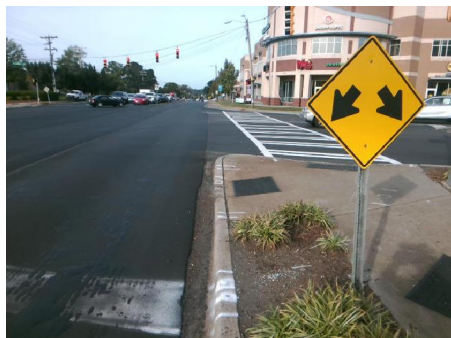
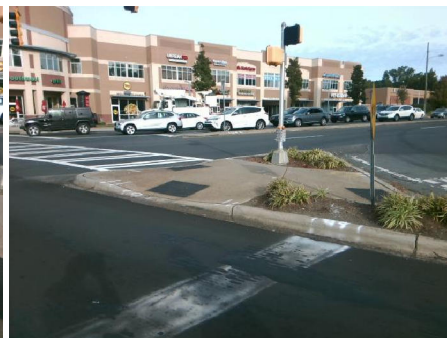
**Not Found, R304.5.1, R304.2.2**

Compliance	Description	Data	Compliance	Description	Data
N/A	Ramp Length (in)	63.0	No	Ramp Slope (%)	13.5
No	Ramp Width (in)	32.0	Yes	Ramp XSlope (%)	0.5
N/A	Flare Type LT	N/A	N/A	Flare Type RT	N/A
N/A	Flare Slope LT (%)	N/A	N/A	Flare Slope RT (%)	N/A
N/A	Flare Traversable LT?	N/A	N/A	Flare Traversable RT?	N/A
N/A	Landing Length (in)	N/A	N/A	DWS Provided?	N/A
N/A	Landing Width (in)	N/A	N/A	DWS Contrast?	N/A
N/A	Landing Slope (%)	N/A	N/A	DWS Length (in)	N/A
N/A	Landing X Slope (%)	N/A	N/A	DWS Full Width?	N/A
N/A	Landing Curb? (Y/N)	N/A	N/A	DWS Offset (in)	N/A
N/A	Shared Landing?	N/A			
N/A	Gutter Ponding?	N/A	N/A	Gutter Slope (%)	N/A
N/A	Gutter Lip Ht (in)	N/A	N/A	Gutter X Slope (%)	N/A
N/A	Painted X Walk1?	No	N/A	Painted X Walk2?	N/A
	X Walk 1 Direction	To SW		X Walk 2 Direction	N/A
N/A	X Walk 1 Width (in)	N/A	N/A	X Walk 2 Width (in)	N/A
	X Walk 1 Slope (%)	1.4		X Walk 2 Slope (%)	N/A
	X Walk 1 X Slope (%)	0.6		X Walk 2 X Slope (%)	N/A

N/A	Ramp inside XWalk1?	N/A	N/A	Ramp inside XWalk2?	N/A
	Road Slope (%)	N/A	N/A	Clear Space?	N/A
	Road X Slope (%)	N/A	N/A	Clear Space to XWalk (in)	N/A
N/A	Any Obstructions?	N/A	N/A	Storm Grate/Utility Hazard?	N/A
	Obstruction Type			Storm Grate/Utility Type	
		N/A			N/A
			Yes	Surface Condition? (G/P)	Good

**Remove & Replace Entire Ramp.**
