Access Compliance Report

Public Rights-of-Way

(Curb Ramps)

Intersection ID: 10025574	Main Street: E_W_T_HARRIS_BV	Cross Street: N/A	Location: SE
ADA ID: 6022D42DDBA7	Ramp Type: Combination1	Initial Pass/Fail: Fail	Overall Compliance: No
			Severity Score: 21.25

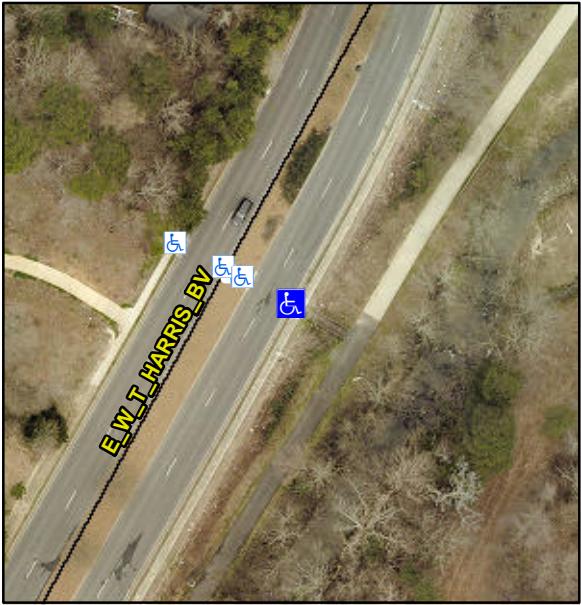
Possible Solutions:		Compliance	Description	Data
	Remove & Replace Entire Ramp.		N/A	Ramp Length LT (in)	85.0
			No	Ramp Width LT (in)	47.0
			Yes	Ramp Slope LT (%)	8.0
			Yes	Ramp XSlope LT (%)	1.1
			N/A	Ramp Length (in)	24.0
			Yes	Ramp Width (in)	59.0
	Surveyor Notes:		N/A	Flare Type LT	N/A
	N/A		N/A	Flare Slope LT (%)	N/A
			N/A	Flare Traversable LT?	N/A
<p>PROW/ADA:</p> <p>R304.5.1, R304.2.2</p>			N/A	Flare Traversable RT?	N/A
			N/A	Landing Length (in)	N/A
			N/A	Landing Width (in)	N/A
			N/A	Landing Slope (%)	N/A
			N/A	Landing X Slope (%)	N/A
			N/A	Landing Curb? (Y/N)	N/A
			N/A	Shared Landing?	N/A
			N/A	Gutter Ponding?	N/A
			N/A	Gutter Lip Ht (in)	N/A
			N/A	Painted X Walk1?	No
<p>Total Cost:</p> <p>\$ 1800.00</p>			N/A	Painted X Walk2?	N/A
				X Walk 1 Direction	To NW
				X Walk 1 Width (in)	N/A
				X Walk 1 Slope (%)	5.3
