Access Compliance Report

Public Rights-of-Way (Curb Ramps)

Intersection ID: 21744	Main Street: BERRY RIDGE RD	Cross Street: RENFROW LN	Location: SW
ADA ID: 602310F45EEB	Ramp Type: BlendTrans2	Initial Pass/Fail: Fail	Overall Compliance: No
Severity Score: 1.25			
Codes/Mitigation Info/Possible Solution		Field Measurements/Component Compliance

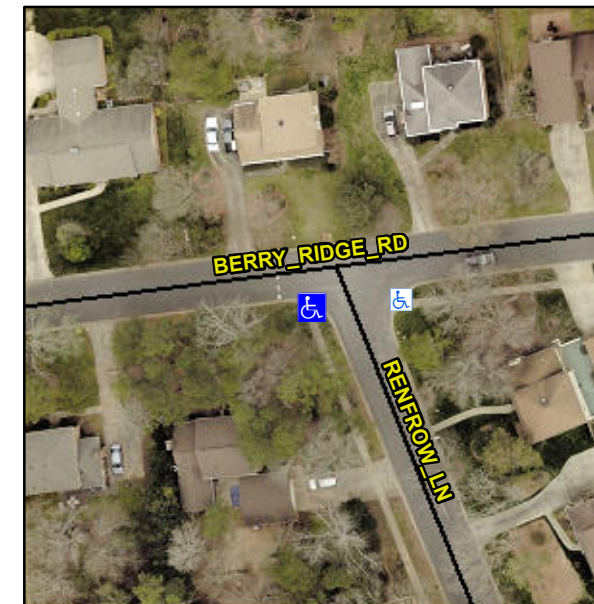
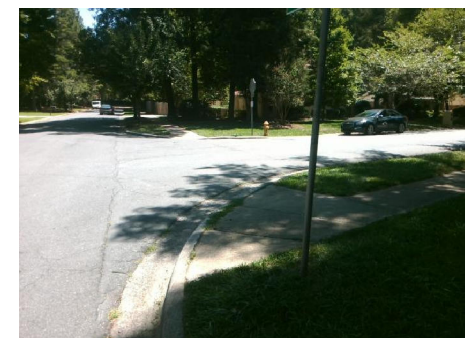
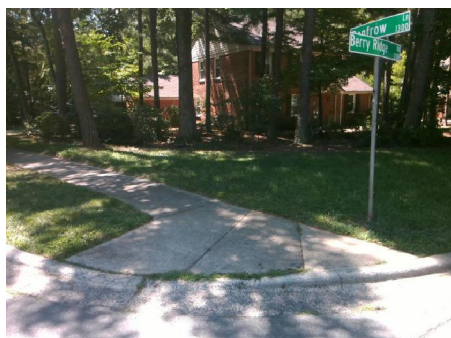
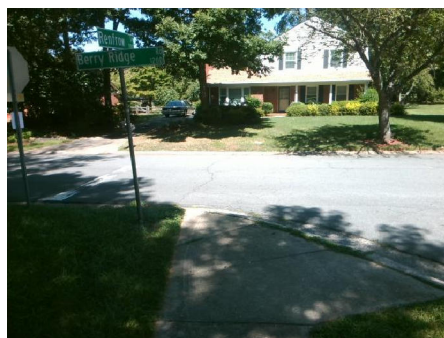
Not Found, R304.5.3

Compliance	Description	Data	Compliance	Description	Data
N/A	Ramp Length (in)	55.0	Yes	BlendTrans Slope (%)	2.7
Yes	Ramp Width (in)	48.0	No	BlendTrans XSlope (%)	2.4
N/A	Flare Type LT	N/A	N/A	Flare Type RT	N/A
N/A	Flare Slope LT (%)	N/A	N/A	Flare Slope RT (%)	N/A
N/A	Flare Traversable LT?	N/A	N/A	Flare Traversable RT?	N/A
N/A	Landing Length (in)	N/A	N/A	DWS Provided?	N/A
N/A	Landing Width (in)	N/A	N/A	DWS Contrast?	N/A
N/A	Landing Slope (%)	N/A	N/A	DWS Length (in)	N/A
N/A	Landing X Slope (%)	N/A	N/A	DWS Full Width?	N/A
N/A	Landing Curb? (Y/N)	N/A	N/A	DWS Offset (in)	N/A
N/A	Shared Landing?	N/A			
N/A	Gutter Ponding?	N/A	N/A	Gutter Slope (%)	N/A
N/A	Gutter Lip Ht (in)	N/A	N/A	Gutter X Slope (%)	N/A
N/A	Painted X Walk1?	No	N/A	Painted X Walk2?	No
	X Walk 1 Direction	To E		X Walk 2 Direction	To N
	X Walk 1 Width (in)	N/A		X Walk 2 Width (in)	N/A
	X Walk 1 Slope (%)	3.5		X Walk 2 Slope (%)	2.3
	X Walk 1 X Slope (%)	0.1		X Walk 2 X Slope (%)	3.4

N/A	Ramp inside XWalk1?	N/A	N/A	Ramp inside XWalk2?	N/A
	Road Slope (%)	0.2		Clear Space?	N/A
	Road X Slope (%)	4.4	N/A	Clear Space to XWalk (in)	N/A
N/A	Any Obstructions?	N/A	N/A	Storm Grate/Utility Hazard?	N/A
	Obstruction Type			Storm Grate/Utility Type	
		N/A			N/A
			Yes	Surface Condition? (G/P)	Good
			No	Curb Slope (%)	11.7

Remove & Replace Curb Ramp With Two New Directional Ramps or Equivalent.
