Access Compliance Report

Public Rights-of-Way

(Curb Ramps)

| Intersection ID: 6021 | Main Street: GIBBON_RD | Cross Street: PLUM_ST | Location: SE |

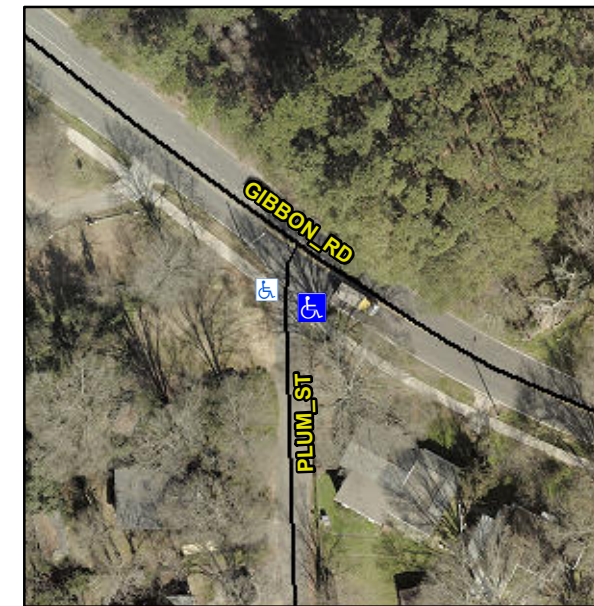
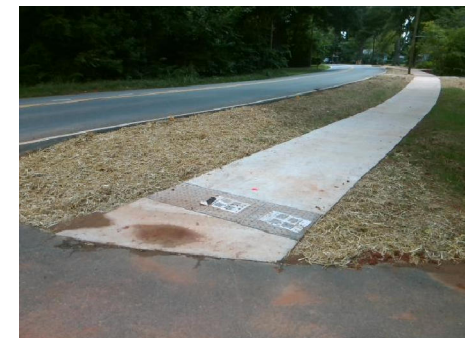
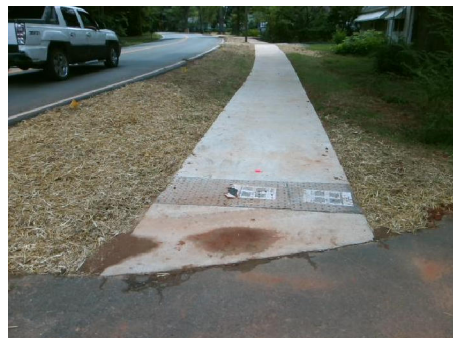
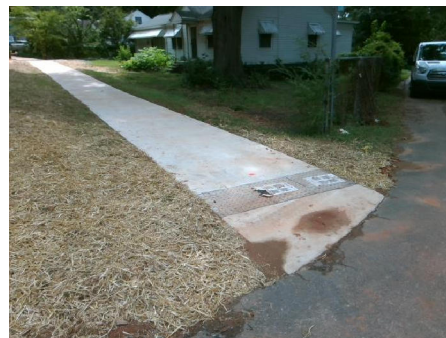
| ADA ID: 602C11FB6810 | Ramp Type: BlendTrans1 | Initial Pass/Fail: Fail | Overall Compliance: No |

NO CURB

R304.5.3

| Compliance | Description | Data | Compliance | Description | Data |
|---|---|---|---|---|---|
| Yes | Ramp Width (in) | 71.5 | No | BlendTrans XSlope (%) | 2.1 |

Remove & Replace Curb Ramp With Two New Directional Ramps or Equivalent.
