Access Compliance Report

Public Rights-of-Way

(Curb Ramps)

Intersection ID: N/A	Main Street: MONROE_RD	Cross Street: N/A	Location: NE
ADA ID: 602C98FB0D93	Ramp Type: Perp	Initial Pass/Fail: Pass	Overall Compliance: No
		Severity Score: 0

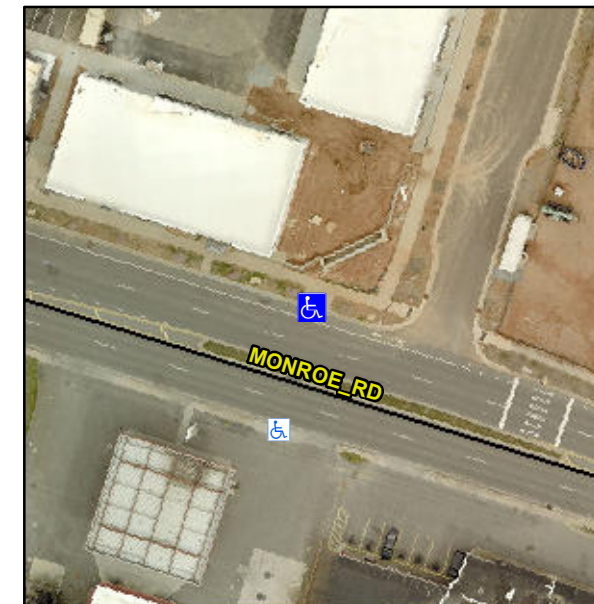
Compliance	Description	Data	Compliance	Description	Data
N/A	Ramp Length (in)	96.0	Yes	Ramp Slope (%)	6.9
Yes	Ramp Width (in)	48.0	Yes	Ramp XSlope (%)	0.3
N/A	Flare Type LT	Sloped	N/A	Flare Type RT	N/A
N/A	Flare Slope LT (%)	6.0	Yes	Flare Slope RT (%)	3.8
N/A	Flare Traversable LT?	Yes	N/A	Flare Traversable RT?	Yes
Yes	Landing Length (in)	69.0	Yes	DWS Provided?	Yes
Yes	Landing Width (in)	48.0	Yes	DWS Contrast?	Yes
Yes	Landing Slope (%)	0.7	Yes	DWS Length (in)	24.0
Yes	Landing X Slope (%)	0.2	Yes	DWS Full Width?	Yes
N/A	Landing Curb? (Y/N)	No	Yes	DWS Offset (in)	0.0
N/A	Shared Landing?	No			
Yes	Gutter Ponding?	No	Yes	Gutter Slope (%)	1.7
Yes	Gutter Lip Ht (in)	0.0	Yes	Gutter X Slope (%)	0.4
N/A	Painted X Walk1?	No	N/A	Painted X Walk2?	N/A
	X Walk 1 Direction	To SW		X Walk 2 Direction	N/A
N/A	X Walk 1 Width (in)	N/A	N/A	X Walk 2 Width (in)	N/A
	X Walk 1 Slope (%)	3.3		X Walk 2 Slope (%)	N/A
	X Walk 1 X Slope (%)	1.2		X Walk 2 X Slope (%)	N/A

N/A	Ramp inside XWalk1?	N/A	N/A	Ramp inside XWalk2?	N/A
	Road Slope (%)	N/A	N/A	Clear Space?	Yes
	Road X Slope (%)	N/A	N/A	Clear Space to XWalk (in)	N/A
Yes	Any Obstructions?	No	Yes	Storm Grate/Utility Hazard?	No
	Obstruction Type			Storm Grate/Utility Type	
		N/A			N/A
			Yes	Surface Condition? (G/P)	Good

Remove & Replace Entire Ramp.
