# Access Compliance Report

## Public Rights-of-Way

### (Curb Ramps)

Intersection ID: 44825	Main Street: SPRING_OAK_DR	Cross Street: HIRAM_ST	Location: SE
ADA ID: 604456170DDB	Ramp Type: PerpDiag	Initial Pass/Fail: Fail	Overall Compliance: No
		Severity Score: 10

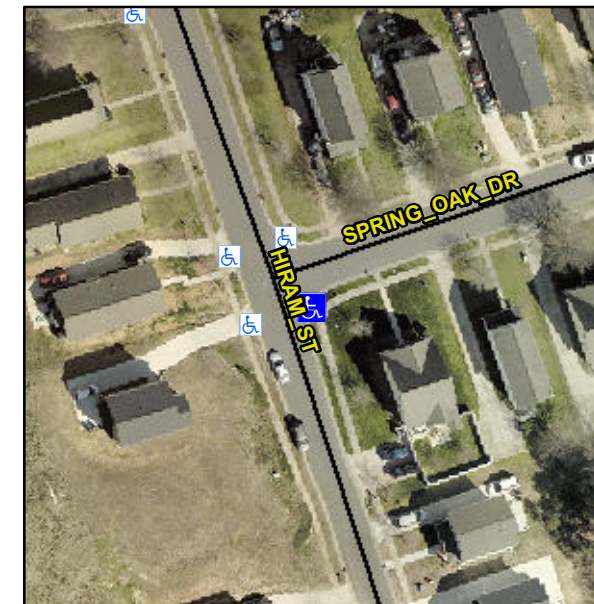
**Not Found, R304.5.1, R304.5.3**

Compliance	Description	Data	Compliance	Description	Data
N/A	Ramp Length (in)	48.0	Yes	Ramp Slope (%)	5.4
No	Ramp Width (in)	43.0	No	Ramp XSlope (%)	2.7
N/A	Flare Type LT	N/A	N/A	Flare Type RT	N/A
N/A	Flare Slope LT (%)	N/A	N/A	Flare Slope RT (%)	N/A
N/A	Flare Traversable LT?	N/A	N/A	Flare Traversable RT?	N/A
N/A	Landing Length (in)	N/A	N/A	DWS Provided?	N/A
N/A	Landing Width (in)	N/A	N/A	DWS Contrast?	N/A
N/A	Landing Slope (%)	N/A	N/A	DWS Length (in)	N/A
N/A	Landing X Slope (%)	N/A	N/A	DWS Full Width?	N/A
N/A	Landing Curb? (Y/N)	N/A	N/A	DWS Offset (in)	N/A
N/A	Shared Landing?	N/A			
N/A	Gutter Ponding?	N/A	N/A	Gutter Slope (%)	N/A
N/A	Gutter Lip Ht (in)	N/A	N/A	Gutter X Slope (%)	N/A
N/A	Painted X Walk1?	No	N/A	Painted X Walk2?	No
	X Walk 1 Direction	To N		X Walk 2 Direction	To W
N/A	X Walk 1 Width (in)	N/A	N/A	X Walk 2 Width (in)	N/A
	X Walk 1 Slope (%)	5.0		X Walk 2 Slope (%)	6.5
	X Walk 1 X Slope (%)	6.0		X Walk 2 X Slope (%)	3.2

N/A	Ramp inside XWalk1?	N/A	N/A	Ramp inside XWalk2?	N/A
	Road Slope (%)	0.4	N/A	Clear Space?	N/A
	Road X Slope (%)	8.1	N/A	Clear Space to XWalk (in)	N/A
N/A	Any Obstructions?	N/A	N/A	Storm Grate/Utility Hazard?	N/A
	Obstruction Type			Storm Grate/Utility Type	
		N/A			N/A
		Yes		Surface Condition? (G/P)	Good

**Remove & Replace Curb Ramp With Two New Directional Ramps or Equivalent.**

Total Cost: \$ 3200.00
