# Access Compliance Report

## Public Rights-of-Way

### (Curb Ramps)

Intersection ID: 20526	Main Street: ARROWCREEK_DR	Cross Street: S_TRYON_ST	Location: NE
ADA ID: 6045D28CD1B0	Ramp Type: Perp	Initial Pass/Fail: Fail	Overall Compliance: No
Severity Score: 21.25			
Codes/Mitigation Info/Possible Solution		Field Measurements/Component Compliance

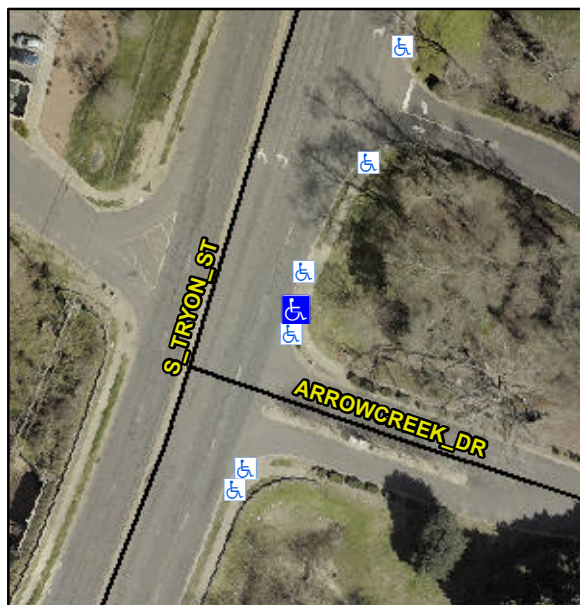
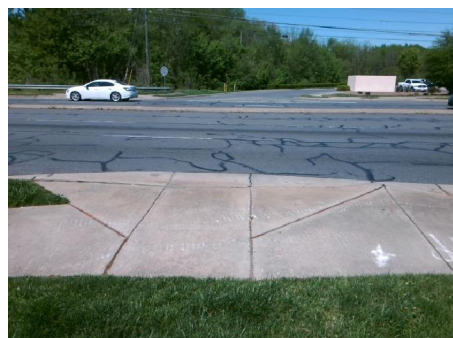
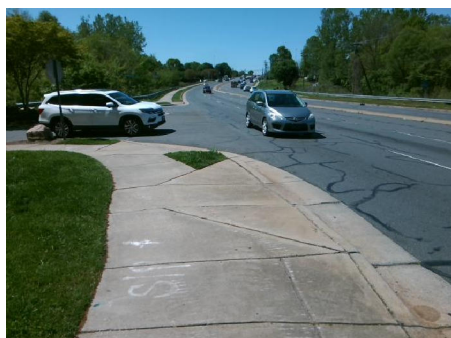
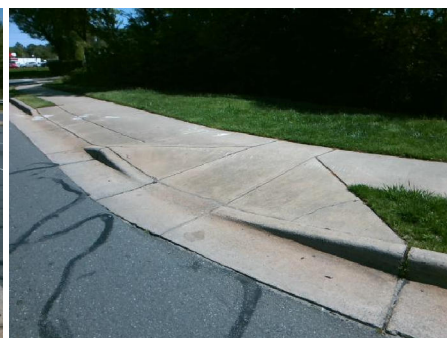
**Not Found, R304.5.1, R304.2.2**

Compliance	Description	Data	Compliance	Description	Data
N/A	Ramp Length (in)	64.5	No	Ramp Slope (%)	9.4
No	Ramp Width (in)	44.0	Yes	Ramp XSlope (%)	0.9
N/A	Flare Type LT	N/A	N/A	Flare Type RT	N/A
N/A	Flare Slope LT (%)	N/A	N/A	Flare Slope RT (%)	N/A
N/A	Flare Traversable LT?	N/A	N/A	Flare Traversable RT?	N/A
N/A	Landing Length (in)	N/A	N/A	DWS Provided?	N/A
N/A	Landing Width (in)	N/A	N/A	DWS Contrast?	N/A
N/A	Landing Slope (%)	N/A	N/A	DWS Length (in)	N/A
N/A	Landing X Slope (%)	N/A	N/A	DWS Full Width?	N/A
N/A	Landing Curb? (Y/N)	N/A	N/A	DWS Offset (in)	N/A
N/A	Shared Landing?	N/A			
N/A	Gutter Ponding?	N/A	N/A	Gutter Slope (%)	N/A
N/A	Gutter Lip Ht (in)	N/A	N/A	Gutter X Slope (%)	N/A
N/A	Painted X Walk1?	No	N/A	Painted X Walk2?	N/A
	X Walk 1 Direction	To W		X Walk 2 Direction	N/A
N/A	X Walk 1 Width (in)	N/A	N/A	X Walk 2 Width (in)	N/A
	X Walk 1 Slope (%)	2.9		X Walk 2 Slope (%)	N/A
	X Walk 1 X Slope (%)	0.5		X Walk 2 X Slope (%)	N/A

N/A	Ramp inside XWalk1?	N/A	N/A	Ramp inside XWalk2?	N/A
	Road Slope (%)	N/A	N/A	Clear Space?	N/A
	Road X Slope (%)	N/A	N/A	Clear Space to XWalk (in)	N/A
N/A	Any Obstructions?	N/A	N/A	Storm Grate/Utility Hazard?	N/A
	Obstruction Type			Storm Grate/Utility Type	
		N/A			N/A
			Yes	Surface Condition? (G/P)	Good

**Remove & Replace Entire Ramp.**

Total Cost: \$ 1850.00
