Access Compliance Report

Public Rights-of-Way

(Curb Ramps)

Intersection ID: 13189	Main Street: HAWTHORNE_LN	Cross Street: SUNNYSIDE_AV	Location: SW
ADA ID: 6050959D89FD	Ramp Type: Perp	Initial Pass/Fail: Fail	Overall Compliance: No
		Severity Score: 25

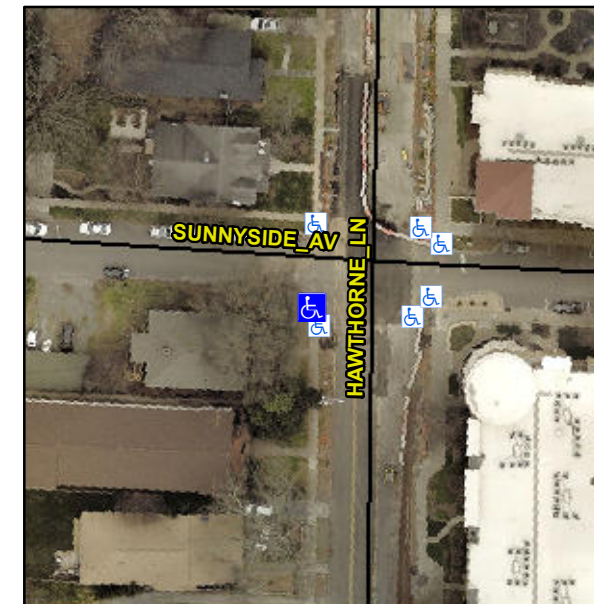
Not Found, R304.2.2, R304.5.3

Compliance	Description	Data	Compliance	Description	Data
N/A	Ramp Length (in)	40.0	No	Ramp Slope (%)	8.5
Yes	Ramp Width (in)	70.0	No	Ramp XSlope (%)	6.3
N/A	Flare Type LT	N/A	N/A	Flare Type RT	N/A
N/A	Flare Slope LT (%)	N/A	N/A	Flare Slope RT (%)	N/A
N/A	Flare Traversable LT?	N/A	N/A	Flare Traversable RT?	N/A
N/A	Landing Length (in)	N/A	N/A	DWS Provided?	N/A
N/A	Landing Width (in)	N/A	N/A	DWS Contrast?	N/A
N/A	Landing Slope (%)	N/A	N/A	DWS Length (in)	N/A
N/A	Landing X Slope (%)	N/A	N/A	DWS Full Width?	N/A
N/A	Landing Curb? (Y/N)	N/A	N/A	DWS Offset (in)	N/A
N/A	Shared Landing?	N/A			
N/A	Gutter Ponding?	N/A	N/A	Gutter Slope (%)	N/A
N/A	Gutter Lip Ht (in)	N/A	N/A	Gutter X Slope (%)	N/A
N/A	Painted X Walk1?	No	N/A	Painted X Walk2?	N/A
	X Walk 1 Direction	To N		X Walk 2 Direction	N/A
N/A	X Walk 1 Width (in)	N/A	N/A	X Walk 2 Width (in)	N/A
	X Walk 1 Slope (%)	0.7		X Walk 2 Slope (%)	N/A
	X Walk 1 X Slope (%)	3.1		X Walk 2 X Slope (%)	N/A

N/A	Ramp inside XWalk1?	N/A	N/A	Ramp inside XWalk2?	N/A
	Road Slope (%)	N/A	N/A	Clear Space?	N/A
	Road X Slope (%)	N/A	N/A	Clear Space to XWalk (in)	N/A
N/A	Any Obstructions?	N/A	N/A	Storm Grate/Utility Hazard?	N/A
	Obstruction Type			Storm Grate/Utility Type	
		N/A			N/A
			Yes	Surface Condition? (G/P)	Good

Remove & Replace Entire Ramp.

Total Cost: \$ 1850.00
