Access Compliance Report

Public Rights-of-Way

(Curb Ramps)

Intersection ID: N/A	Main Street: ELEANOR_RIGBY_RD	Cross Street: MOONLIGHT_BAY_WY	Location: SE
ADA ID: 605498F4BB70	Ramp Type: BlendTrans1	Initial Pass/Fail: Fail	Overall Compliance: No
		Severity Score: 8.75

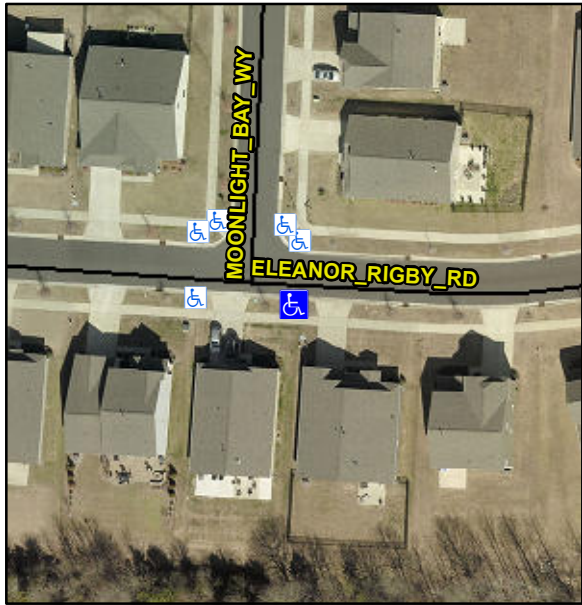
Possible Solutions:		Compliance	Description	Data	Compliance	Description	Data
	Remove & Replace Curb Ramp With Two New Directional Ramps or Equivalent.		N/A	Ramp Length (in)	95.0	Yes	BlendTrans Slope (%)	2.7
			No	Ramp Width (in)	46.5	Yes	BlendTrans XSlope (%)	0.7
			N/A	Flare Type LT	N/A	N/A	Flare Type RT	N/A
			N/A	Flare Slope LT (%)	N/A	N/A	Flare Slope RT (%)	N/A
			N/A	Flare Traversable LT?	N/A	N/A	Flare Traversable RT?	N/A
			N/A	Landing Length (in)	N/A	N/A	DWS Provided?	N/A
			N/A	Landing Width (in)	N/A	N/A	DWS Contrast?	N/A
			N/A	Landing Slope (%)	N/A	N/A	DWS Length (in)	N/A
			N/A	Landing X Slope (%)	N/A	N/A	DWS Full Width?	N/A
Surveyor Notes:	N/A		N/A	Landing Curb? (Y/N)	N/A	N/A	DWS Offset (in)	N/A
			N/A	Shared Landing?	N/A			
	PROW/ADA:		N/A	Gutter Ponding?	N/A	N/A	Gutter Slope (%)	N/A
	R304.5.1		N/A	Gutter Lip Ht (in)	N/A	N/A	Gutter X Slope (%)	N/A

N/A	Painted X Walk1?	No	N/A	Painted X Walk2?	N/A
				X Walk 1 Direction	To N		X Walk 2 Direction	N/A
				X Walk 1 Width (in)	N/A		X Walk 2 Width (in)	N/A
				X Walk 1 Slope (%)	2.7		X Walk 2 Slope (%)	N/A
				X Walk 1 X Slope (%)	0.3		X Walk 2 X Slope (%)	N/A
			N/A	Ramp inside XWalk1?	N/A	N/A	Ramp inside XWalk2?	N/A
			Road Slope (%)	0.3		Clear Space?	N/A	
			Road X Slope (%)	2.7	N/A	Clear Space to XWalk (in)	N/A	
		N/A	Any Obstructions?	N/A	N/A	Storm Grate/Utility Hazard?	N/A	
			Obstruction Type			Storm Grate/Utility Type		
					N/A			N/A
						Yes	Surface Condition? (G/P)	Good
						N/A	Curb Slope (%)	0.1
