# Access Compliance Report

## Public Rights-of-Way

### (Curb Ramps)

| Intersection ID: 3999 | Main Street: CULLINGFORD_LN | Cross Street: AMBLESIDE_DR | Location: NW |

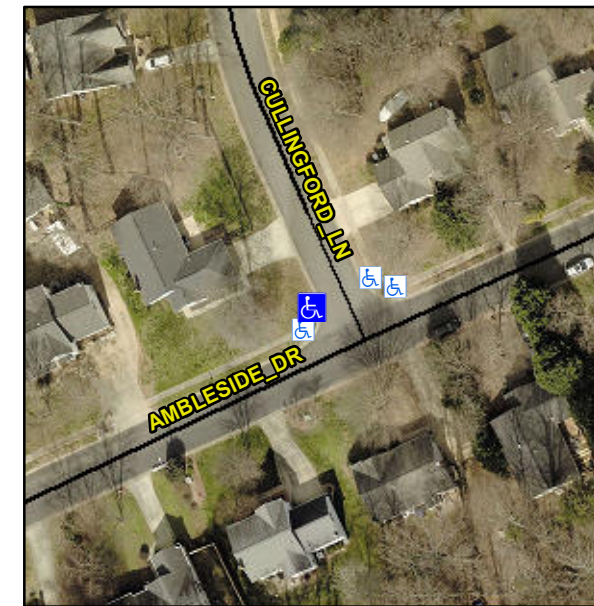
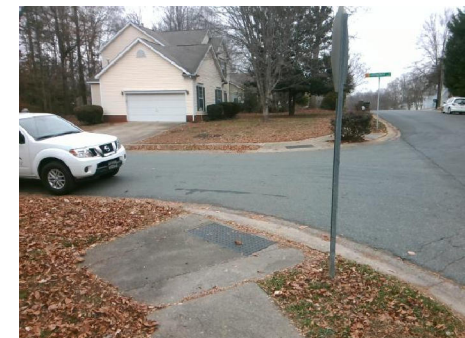
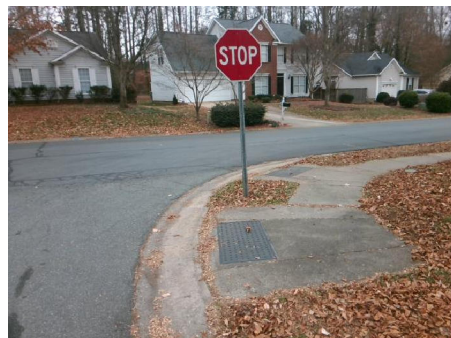
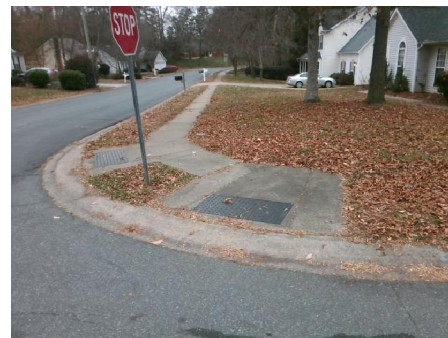
| ADA ID: 60597B7D7FE6 | Ramp Type: BlendTrans2 | Initial Pass/Fail: Fail | Overall Compliance: No |
| | | | Severity Score: 18.75 |

**Not Found, R304.5.1, R304.5.3**

| Compliance | Description | Data | Compliance | Description | Data |
|---|---|---|---|---|---|
| No | Ramp Width (in) | 34.0 | No | BlendTrans XSlope (%) | 2.8 |

Possible Solutions:

**Remove & Replace Curb Ramp With Two New Directional Ramps or Equivalent.**

Total Cost: \$ 3200.00
