# Access Compliance Report

## Public Rights-of-Way

### (Curb Ramps)

Intersection ID: 46818	Main Street: HOLM_OAK_PL	Cross Street: AZALEA_HILLS_DR	Location: W
ADA ID: 605DE4614FCB	Ramp Type: Perp	Initial Pass/Fail: Fail	Overall Compliance: No
Severity Score: 33.75			
Codes/Mitigation Info/Possible Solution		Field Measurements/Component Compliance

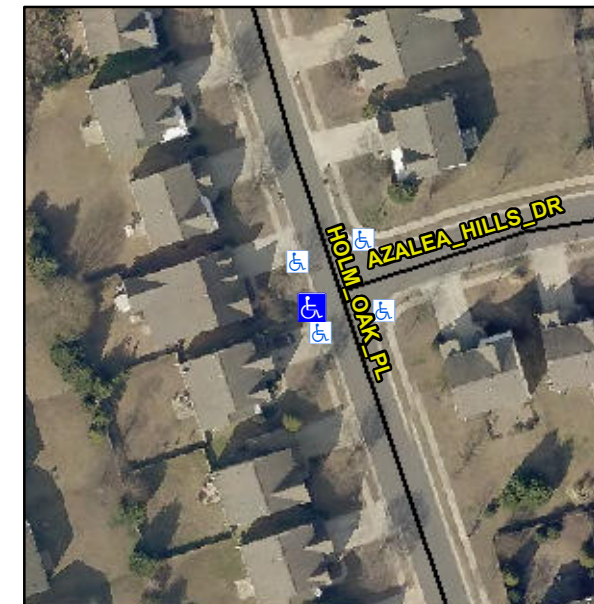
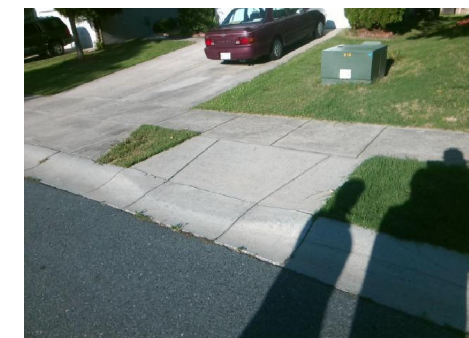
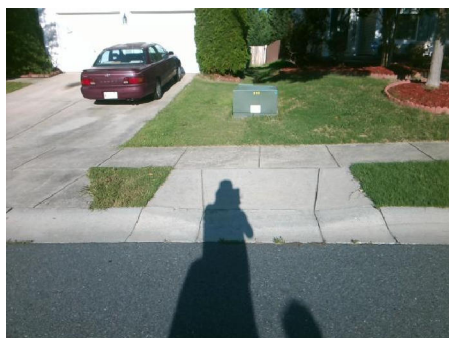
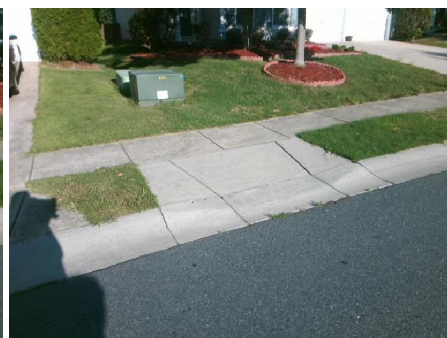
**R304.5.1, R304.2.2, R304.5.3**

Compliance	Description	Data	Compliance	Description	Data
N/A	Ramp Length (in)	47.0	No	Ramp Slope (%)	9.1
No	Ramp Width (in)	46.0	No	Ramp XSlope (%)	5.1
N/A	Flare Type LT	N/A	N/A	Flare Type RT	N/A
N/A	Flare Slope LT (%)	N/A	N/A	Flare Slope RT (%)	N/A
N/A	Flare Traversable LT?	N/A	N/A	Flare Traversable RT?	N/A
N/A	Landing Length (in)	N/A	N/A	DWS Provided?	N/A
N/A	Landing Width (in)	N/A	N/A	DWS Contrast?	N/A
N/A	Landing Slope (%)	N/A	N/A	DWS Length (in)	N/A
N/A	Landing X Slope (%)	N/A	N/A	DWS Full Width?	N/A
N/A	Landing Curb? (Y/N)	N/A	N/A	DWS Offset (in)	N/A
N/A	Shared Landing?	N/A			
N/A	Gutter Ponding?	N/A	N/A	Gutter Slope (%)	N/A
N/A	Gutter Lip Ht (in)	N/A	N/A	Gutter X Slope (%)	N/A
N/A	Painted X Walk1?	No	N/A	Painted X Walk2?	N/A
	X Walk 1 Direction	To E		X Walk 2 Direction	N/A
N/A	X Walk 1 Width (in)	N/A	N/A	X Walk 2 Width (in)	N/A
	X Walk 1 Slope (%)	3.2		X Walk 2 Slope (%)	N/A
	X Walk 1 X Slope (%)	3.3		X Walk 2 X Slope (%)	N/A

N/A	Ramp inside XWalk1?	N/A	N/A	Ramp inside XWalk2?	N/A
	Road Slope (%)	N/A	N/A	Clear Space?	N/A
	Road X Slope (%)	N/A	N/A	Clear Space to XWalk (in)	N/A
N/A	Any Obstructions?	N/A	N/A	Storm Grate/Utility Hazard?	N/A
	Obstruction Type			Storm Grate/Utility Type	
		N/A			N/A
			Yes	Surface Condition? (G/P)	Good

**Remove & Replace Entire Ramp.**

Total Cost: \$ 1850.00
