# Access Compliance Report

## Public Rights-of-Way

### (Curb Ramps)

| Intersection ID: 16828 | Main Street: BUCKNELL_AV | Cross Street: SELWYN_AV | Location: NW |

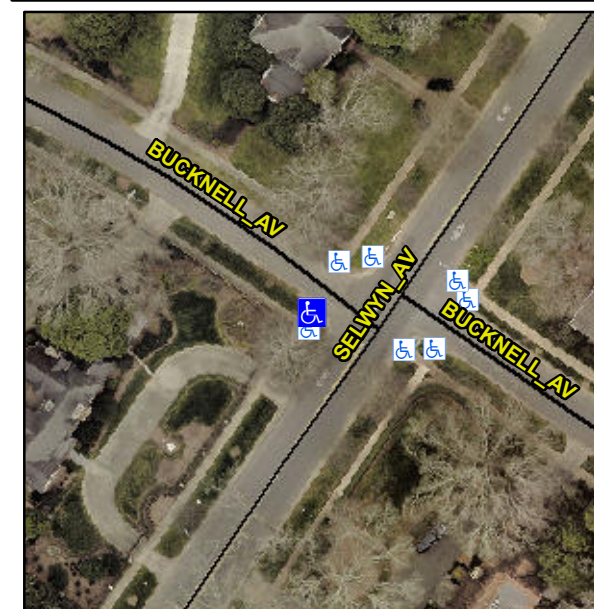
| ADA ID: 6061303950BF | Ramp Type: Perp | Initial Pass/Fail: Fail | Overall Compliance: No |
| Severity Score: 1.25 | | | |

**R304.5.3**

| Compliance | Description | Data | Compliance | Description | Data |
|---|---|---|---|---|---|
| N/A | Ramp Length (in) | 98.0 | Yes | Ramp Slope (%) | 5.1 |
| Yes | Ramp Width (in) | 58.0 | No | Ramp XSlope (%) | 3.3 |
| | | Yes | | Surface Condition? (G/P) | Good |

**Remove & Replace Entire Ramp.**

**\$ 1850.00**
