# Access Compliance Report

## Public Rights-of-Way

### (Curb Ramps)

| Intersection ID: 50578 | Main Street: PAPER_TREE_RD | Cross Street: BENDING_BRANCH_RD | Location: W |

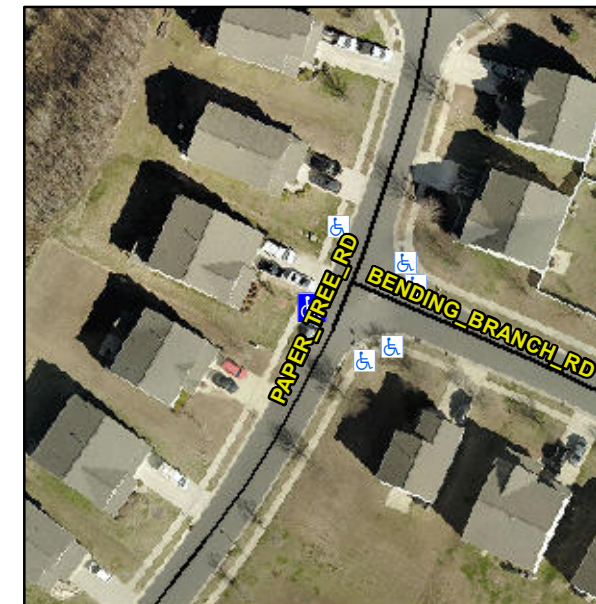
| ADA ID: 60617793D23F | Ramp Type: Perp | Initial Pass/Fail: Fail | Overall Compliance: No |
| Severity Score: 22.5 | | | |

**Not Found, R304.5.1, R304.2.2, R304.5.3**

| Compliance | Description | Data | Compliance | Description | Data |
|---|---|---|---|---|---|
| N/A | Ramp Length (in) | 48.0 | No | Ramp Slope (%) | 10.6 |
| No | Ramp Width (in) | 47.5 | No | Ramp XSlope (%) | 3.1 |

Possible Solutions:

**Remove & Replace Entire Ramp.**

Total Cost: \$ 1850.00
