Access Compliance Report

Public Rights-of-Way

(Curb Ramps)

Intersection ID: 16185	Main Street: DORIS_AV	Cross Street: RICHLAND_DR	Location: S
ADA ID: 60621727EDCE	Ramp Type: BlendTrans1	Initial Pass/Fail: Fail	Overall Compliance: No
Severity Score: 8.75			
Codes/Mitigation Info/Possible Solution		Field Measurements/Component Compliance

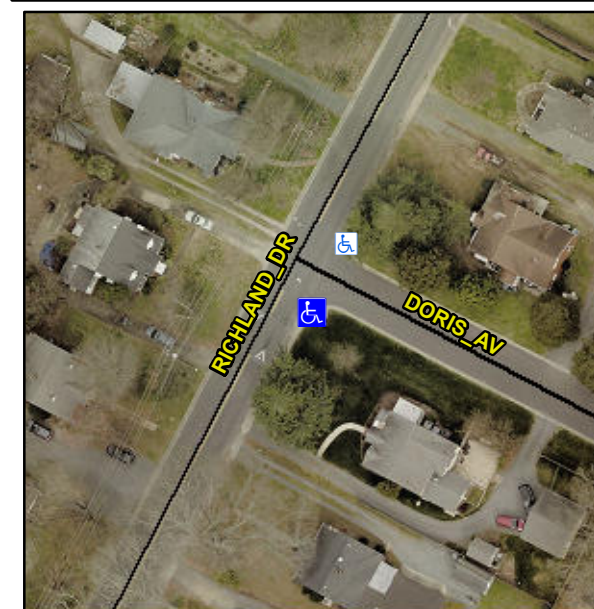
NO LT SW

Compliance	Description	Data	Compliance	Description	Data
N/A	Ramp Length (in)	61.0	Yes	BlendTrans Slope (%)	1.4
No	Ramp Width (in)	37.0	Yes	BlendTrans XSlope (%)	1.4
N/A	Flare Type LT	N/A	N/A	Flare Type RT	N/A
N/A	Flare Slope LT (%)	N/A	N/A	Flare Slope RT (%)	N/A
N/A	Flare Traversable LT?	N/A	N/A	Flare Traversable RT?	N/A
N/A	Landing Length (in)	N/A	N/A	DWS Provided?	N/A
N/A	Landing Width (in)	N/A	N/A	DWS Contrast?	N/A
N/A	Landing Slope (%)	N/A	N/A	DWS Length (in)	N/A
N/A	Landing X Slope (%)	N/A	N/A	DWS Full Width?	N/A
N/A	Landing Curb? (Y/N)	N/A	N/A	DWS Offset (in)	N/A
N/A	Shared Landing?	N/A			
N/A	Gutter Ponding?	N/A	N/A	Gutter Slope (%)	N/A
N/A	Gutter Lip Ht (in)	N/A	N/A	Gutter X Slope (%)	N/A
N/A	Painted X Walk1?	No	N/A	Painted X Walk2?	N/A
	X Walk 1 Direction	To NE		X Walk 2 Direction	N/A
	X Walk 1 Width (in)	N/A		X Walk 2 Width (in)	N/A
	X Walk 1 Slope (%)	0.2		X Walk 2 Slope (%)	N/A
	X Walk 1 X Slope (%)	3.1		X Walk 2 X Slope (%)	N/A

N/A	Ramp inside XWalk1?	N/A	N/A	Ramp inside XWalk2?	N/A
	Road Slope (%)	3.1		Clear Space?	N/A
	Road X Slope (%)	0.2	N/A	Clear Space to XWalk (in)	N/A
N/A	Any Obstructions?	N/A	N/A	Storm Grate/Utility Hazard?	N/A
	Obstruction Type			Storm Grate/Utility Type	
		N/A			N/A
			Yes	Surface Condition? (G/P)	Good
			N/A	Curb Slope (%)	1.2

Remove & Replace Curb Ramp With Two New Directional Ramps or Equivalent.

R304.5.1
