Access Compliance Report

Public Rights-of-Way

(Curb Ramps)

Intersection ID: 29810	Main Street: MCCLURE_MANOR_DR	Cross Street: SYDENHAM_CT	Location: SW
ADA ID: 6067F8D7BAD6	Ramp Type: Perp	Initial Pass/Fail: Fail	Overall Compliance: No
Severity Score: 25			
Codes/Mitigation Info/Possible Solution		Field Measurements/Component Compliance

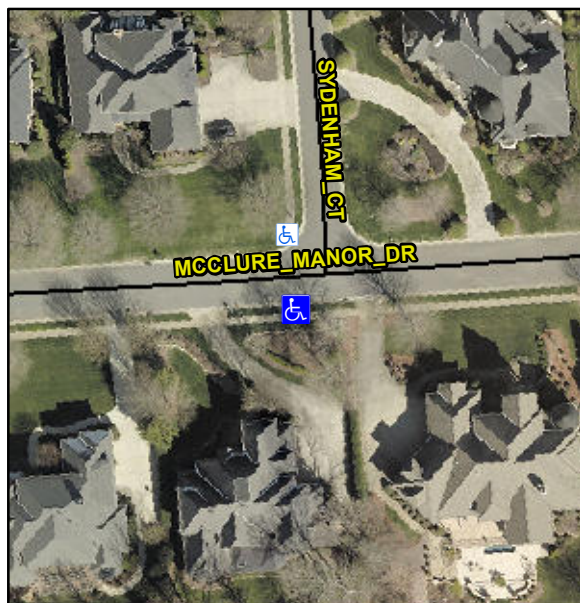
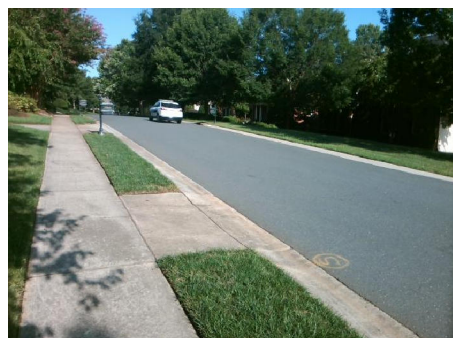
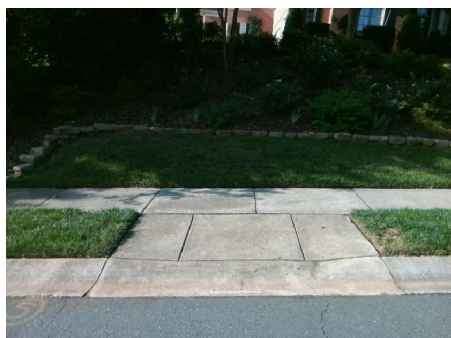
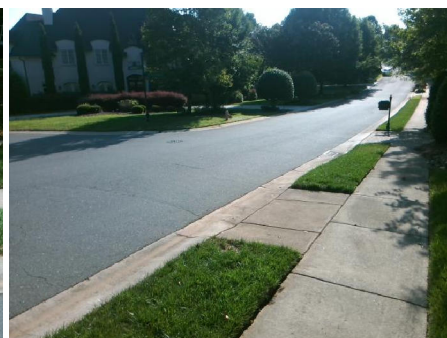
Not Found, R304.5.3

Compliance	Description	Data	Compliance	Description	Data
N/A	Ramp Length (in)	47.0	Yes	Ramp Slope (%)	8.0
Yes	Ramp Width (in)	53.0	No	Ramp XSlope (%)	8.2
N/A	Flare Type LT	N/A	N/A	Flare Type RT	N/A
N/A	Flare Slope LT (%)	N/A	N/A	Flare Slope RT (%)	N/A
N/A	Flare Traversable LT?	N/A	N/A	Flare Traversable RT?	N/A
N/A	Landing Length (in)	N/A	N/A	DWS Provided?	N/A
N/A	Landing Width (in)	N/A	N/A	DWS Contrast?	N/A
N/A	Landing Slope (%)	N/A	N/A	DWS Length (in)	N/A
N/A	Landing X Slope (%)	N/A	N/A	DWS Full Width?	N/A
N/A	Landing Curb? (Y/N)	N/A	N/A	DWS Offset (in)	N/A
N/A	Shared Landing?	N/A			
N/A	Gutter Ponding?	N/A	N/A	Gutter Slope (%)	N/A
N/A	Gutter Lip Ht (in)	N/A	N/A	Gutter X Slope (%)	N/A
N/A	Painted X Walk1?	No	N/A	Painted X Walk2?	N/A
	X Walk 1 Direction	To N		X Walk 2 Direction	N/A
N/A	X Walk 1 Width (in)	N/A	N/A	X Walk 2 Width (in)	N/A
	X Walk 1 Slope (%)	0.2		X Walk 2 Slope (%)	N/A
	X Walk 1 X Slope (%)	7.0		X Walk 2 X Slope (%)	N/A

N/A	Ramp inside XWalk1?	N/A	N/A	Ramp inside XWalk2?	N/A
	Road Slope (%)	N/A	N/A	Clear Space?	N/A
	Road X Slope (%)	N/A	N/A	Clear Space to XWalk (in)	N/A
N/A	Any Obstructions?	N/A	N/A	Storm Grate/Utility Hazard?	N/A
	Obstruction Type			Storm Grate/Utility Type	
		N/A			N/A
		Yes		Surface Condition? (G/P)	Good

Remove & Replace Entire Ramp.

Total Cost: \$ 1850.00
