Access Compliance Report

Public Rights-of-Way

(Curb Ramps)

Intersection ID: 18026	Main Street: E_INDEPENDENCE_BV	Cross Street: WALLACE_LN	Location: SE
ADA ID: 6069B4F5D67F	Ramp Type: ParaDiag	Initial Pass/Fail: Fail	Overall Compliance: No
Severity Score: 13.75			
Codes/Mitigation Info/Possible Solution		Field Measurements/Component Compliance

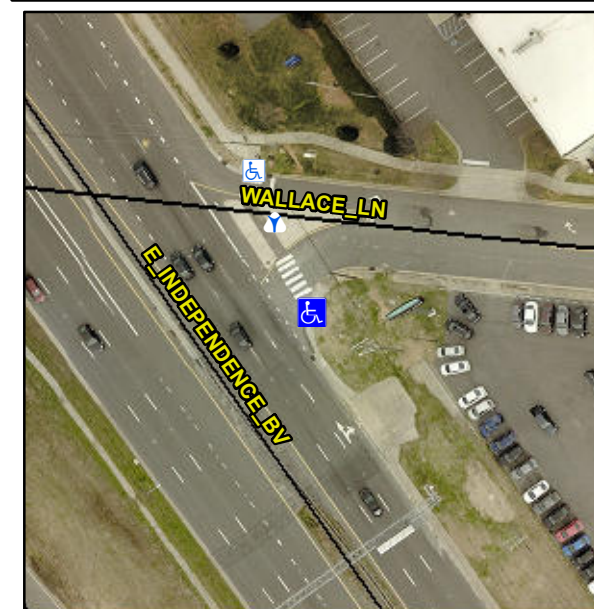
RT RP < 5%

PROW/ADA:

R304.3.2, R304.5.3

Compliance	Description	Data	Compliance	Description	Data
N/A	Ramp Length LT (in)	65.0	N/A	Ramp Length RT (in)	68.0
Yes	Ramp Width LT (in)	51.0	Yes	Ramp Width RT (in)	53.0
No	Ramp Slope LT (%)	8.7	Yes	Ramp Slope RT (%)	3.7
No	Ramp XSlope LT (%)	2.2	Yes	Ramp XSlope RT (%)	1.0
N/A	Landing Length (in)	N/A	N/A	DWS Provided?	N/A
N/A	Landing Width (in)	N/A	N/A	DWS Contrast?	N/A
N/A	Landing Slope (%)	N/A	N/A	DWS Length (in)	N/A
N/A	Landing X Slope (%)	N/A	N/A	DWS Full Width?	N/A
N/A	Landing Curb? (Y/N)	N/A	N/A	DWS Offset (in)	N/A
N/A	Shared Landing?	N/A			
N/A	Gutter Ponding?	N/A	N/A	Gutter Slope (%)	N/A
N/A	Gutter Lip Ht (in)	N/A	N/A	Gutter X Slope (%)	N/A
N/A	Painted X Walk1?	Yes	N/A	Painted X Walk2?	No
	X Walk 1 Direction	To NW		X Walk 2 Direction	To SW
N/A	X Walk 1 Width (in)	120.0	N/A	X Walk 2 Width (in)	N/A
	X Walk 1 Slope (%)	3.0		X Walk 2 Slope (%)	2.7
	X Walk 1 X Slope (%)	0.9		X Walk 2 X Slope (%)	3.6
N/A	Ramp inside XWalk1?	Yes	N/A	Ramp inside XWalk2?	N/A

Road Slope (%)	2.0	N/A	Clear Space?	N/A
	Road X Slope (%)	3.8	N/A	Clear Space to XWalk (in)	N/A
N/A	Any Obstructions?	N/A	N/A	Storm Grate/Utility Hazard?	N/A
	Obstruction Type			Storm Grate/Utility Type	
		N/A			N/A
			Yes	Surface Condition? (G/P)	Good
			N/A	Curb Slope (%)	14.7

Possible Solutions:

Remove & Replace Curb Ramp With Two New Directional Ramps or Equivalent.
