# Access Compliance Report

## Public Rights-of-Way

### (Curb Ramps)

Intersection ID: 43495	Main Street: PROVENCE_LN	Cross Street: PRESCOTT_HILL_AV	Location: SW
ADA ID: 607904C6C3C4	Ramp Type: PerpDiag	Initial Pass/Fail: Fail	Overall Compliance: No
			Severity Score: 46.25

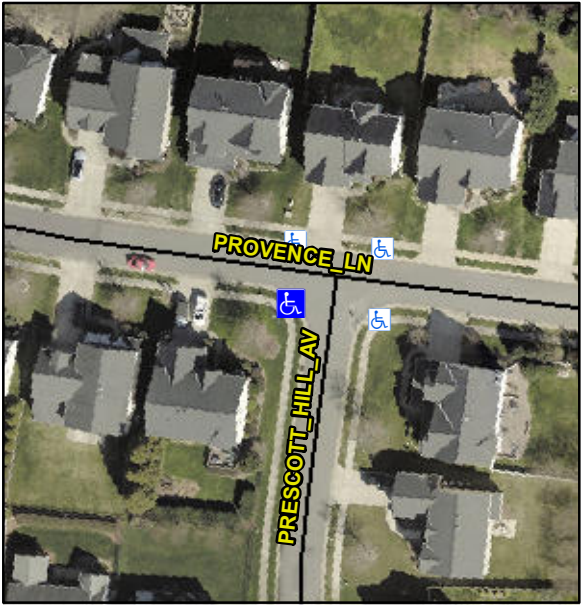
Possible Solutions:		<b>Compliance</b>	<b>Description</b>	<b>Data</b>
	<b>Remove &amp; Replace Curb Ramp With Two New Directional Ramps or Equivalent.</b>		<b>No</b>	Ramp Length (in)	<b>44.5</b>
			<b>No</b>	Ramp Width (in)	<b>41.0</b>
			<b>N/A</b>	Flare Type LT	<b>N/A</b>
			<b>N/A</b>	Flare Slope LT (%)	<b>N/A</b>
			<b>N/A</b>	Flare Traversable LT?	<b>N/A</b>
			<b>N/A</b>	Landing Length (in)	<b>N/A</b>
			<b>N/A</b>	Landing Width (in)	<b>N/A</b>
			<b>N/A</b>	Landing Slope (%)	<b>N/A</b>
			<b>N/A</b>	Landing X Slope (%)	<b>N/A</b>
<p>Surveyor Notes:</p> <p><b>N/A</b></p> <p>PROW/ADA:</p> <p><b>Not Found, R304.5.1, R304.2.2, R304.5.3</b></p>			<b>N/A</b>	Flare Type RT	<b>N/A</b>
			<b>N/A</b>	Flare Slope RT (%)	<b>N/A</b>
			<b>N/A</b>	Flare Traversable RT?	<b>N/A</b>
			<b>N/A</b>	DWS Provided?	<b>N/A</b>
			<b>N/A</b>	DWS Contrast?	<b>N/A</b>

<b>N/A</b>	DWS Length (in)	<b>N/A</b>
			<b>N/A</b>	DWS Full Width?	<b>N/A</b>
			<b>N/A</b>	DWS Offset (in)	<b>N/A</b>
			<b>N/A</b>	Gutter Ponding?	<b>N/A</b>
			<b>N/A</b>	Gutter Lip Ht (in)	<b>N/A</b>
			<b>No</b>	Painted X Walk1?	<b>No</b>
			<b>To SE</b>	X Walk 1 Direction	<b>To N</b>
			<b>N/A</b>	X Walk 1 Width (in)	<b>N/A</b>
			<b>1.0</b>	X Walk 1 Slope (%)	<b>3.9</b>
			<b>5.3</b>	X Walk 1 X Slope (%)	<b>4.3</b>
			<b>N/A</b>	Ramp inside XWalk1?	<b>N/A</b>
			<b>5.4</b>	Road Slope (%)	<b>N/A</b>
			<b>3.1</b>	Road X Slope (%)	<b>N/A</b>
			<b>N/A</b>	Any Obstructions?	<b>N/A</b>
			<b>N/A</b>	Obstruction Type	<b>N/A</b>
Total Cost:			<b>\$</b>	<b>3200.00</b>	
			<b>N/A</b>		<b>N/A</b>
			<b>Yes</b>	Surface Condition? (G/P)	<b>Good</b>
