# Access Compliance Report

## Public Rights-of-Way

### (Curb Ramps)

Intersection ID: 49691	Main Street: OLIVIA_VIEW_CT	Cross Street: ALEXANDRA_ALLEY_DR	Location: W
ADA ID: 607992E181EB	Ramp Type: Perp	Initial Pass/Fail: Fail	Overall Compliance: No
Severity Score: 22.5			
Codes/Mitigation Info/Possible Solution		Field Measurements/Component Compliance

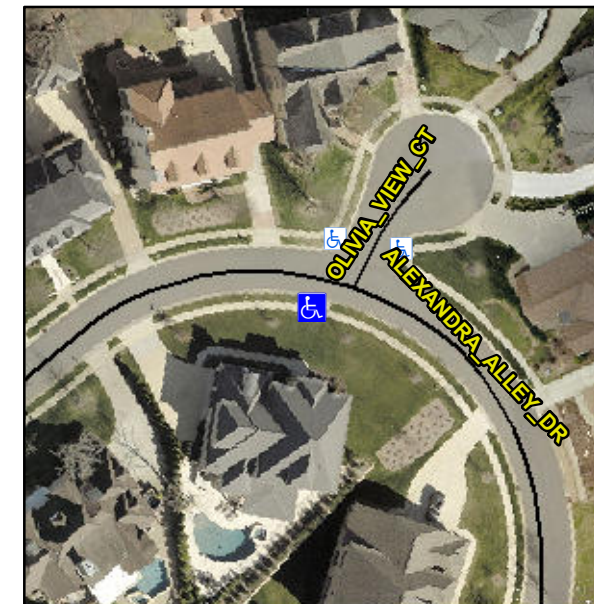
Compliance	Description	Data	Compliance	Description	Data
N/A	Ramp Length (in)	47.5	No	Ramp Slope (%)	10.8
No	Ramp Width (in)	47.0	No	Ramp XSlope (%)	2.7
N/A	Flare Type LT	N/A	N/A	Flare Type RT	N/A
N/A	Flare Slope LT (%)	N/A	N/A	Flare Slope RT (%)	N/A
N/A	Flare Traversable LT?	N/A	N/A	Flare Traversable RT?	N/A
N/A	Landing Length (in)	N/A	N/A	DWS Provided?	N/A
N/A	Landing Width (in)	N/A	N/A	DWS Contrast?	N/A
N/A	Landing Slope (%)	N/A	N/A	DWS Length (in)	N/A
N/A	Landing X Slope (%)	N/A	N/A	DWS Full Width?	N/A
N/A	Landing Curb? (Y/N)	N/A	N/A	DWS Offset (in)	N/A
N/A	Shared Landing?	N/A			
N/A	Gutter Ponding?	N/A	N/A	Gutter Slope (%)	N/A
N/A	Gutter Lip Ht (in)	N/A	N/A	Gutter X Slope (%)	N/A
N/A	Painted X Walk1?	No	N/A	Painted X Walk2?	N/A
	X Walk 1 Direction	To NE		X Walk 2 Direction	N/A
N/A	X Walk 1 Width (in)	N/A	N/A	X Walk 2 Width (in)	N/A
	X Walk 1 Slope (%)	2.8		X Walk 2 Slope (%)	N/A
	X Walk 1 X Slope (%)	2.1		X Walk 2 X Slope (%)	N/A

N/A	Ramp inside XWalk1?	N/A	N/A	Ramp inside XWalk2?	N/A
	Road Slope (%)	N/A	N/A	Clear Space?	N/A
	Road X Slope (%)	N/A	N/A	Clear Space to XWalk (in)	N/A
N/A	Any Obstructions?	N/A	N/A	Storm Grate/Utility Hazard?	N/A
	Obstruction Type			Storm Grate/Utility Type	
		N/A			N/A
			Yes	Surface Condition? (G/P)	Good

**Remove & Replace Entire Ramp.**

**R304.5.1, R304.2.2, R304.5.3**
