# Access Compliance Report

## Public Rights-of-Way

### (Curb Ramps)

Intersection ID: N/A	Main Street: TREESDALE LN	Cross Street: SHOFF CIR	Location: W
ADA ID: 609C073201E7	Ramp Type: Perpendicular	Initial Pass/Fail: Fail	Overall Compliance: No
Severity Score: 1.25			
Codes/Mitigation Info/Possible Solution		Field Measurements/Component Compliance

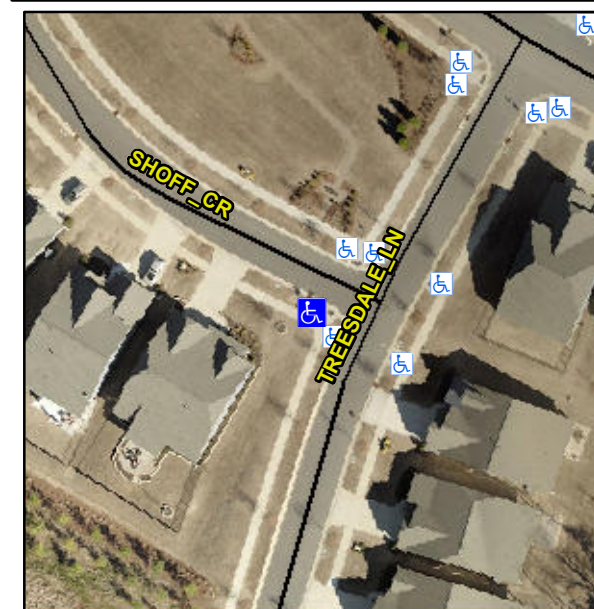
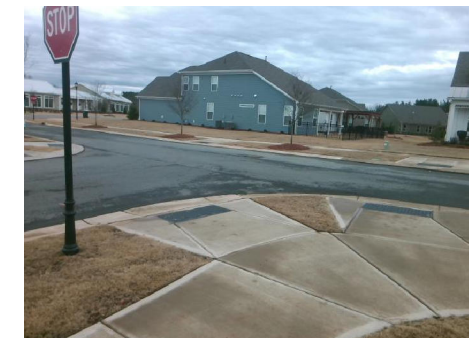
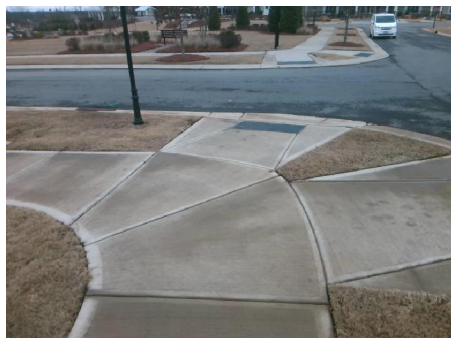
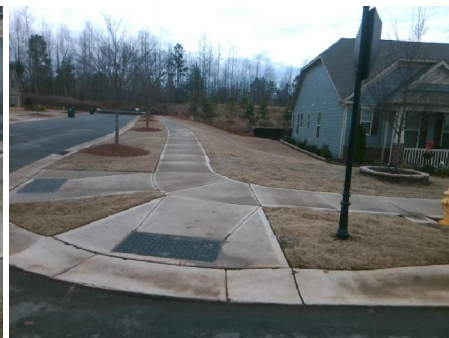
**Not Found, R304.5.3**

Compliance	Description	Data	Compliance	Description	Data
N/A	Ramp Length (in)	95.0	Yes	Ramp Slope (%)	7.2
Yes	Ramp Width (in)	48.0	No	Ramp XSlope (%)	4.2
N/A	Flare Type LT	N/A	N/A	Flare Type RT	N/A
N/A	Flare Slope LT (%)	N/A	N/A	Flare Slope RT (%)	N/A
N/A	Flare Traversable LT?	No	N/A	Flare Traversable RT?	No
N/A	Landing Length (in)	N/A	N/A	DWS Provided?	N/A
N/A	Landing Width (in)	N/A	N/A	DWS Contrast?	N/A
N/A	Landing Slope (%)	N/A	N/A	DWS Length (in)	N/A
N/A	Landing X Slope (%)	N/A	N/A	DWS Full Width?	N/A
N/A	Landing Curb? (Y/N)	N/A	N/A	DWS Offset (in)	N/A
N/A	Shared Landing?	N/A			
N/A	Gutter Ponding?	N/A	N/A	Gutter Slope (%)	N/A
N/A	Gutter Lip Ht (in)	N/A	N/A	Gutter X Slope (%)	N/A
N/A	Painted X Walk1?	No	N/A	Painted X Walk2?	N/A
	X Walk 1 Direction	To NE		X Walk 2 Direction	N/A
N/A	X Walk 1 Width (in)	N/A	N/A	X Walk 2 Width (in)	N/A
	X Walk 1 Slope (%)	3.0		X Walk 2 Slope (%)	N/A
	X Walk 1 X Slope (%)	3.8		X Walk 2 X Slope (%)	N/A

N/A	Ramp inside XWalk1?	N/A	N/A	Ramp inside XWalk2?	N/A
	Road Slope (%)	N/A	N/A	Clear Space?	N/A
	Road X Slope (%)	N/A	N/A	Clear Space to XWalk (in)	N/A
N/A	Any Obstructions?	N/A	N/A	Storm Grate/Utility Hazard?	N/A
	Obstruction Type			Storm Grate/Utility Type	
		N/A			N/A
		Yes		Surface Condition? (G/P)	Good

**Remove & Replace Entire Ramp.**
