Access Compliance Report

Public Rights-of-Way

(Curb Ramps)

Intersection ID: 54324	Main Street: BELMONT_MANSION_DR	Cross Street: ROCKY_HILL_CASTLE_DR	Location: SE
ADA ID: 60A14A55732F	Ramp Type: BlendTrans1	Initial Pass/Fail: Fail	Overall Compliance: No
Codes/Mitigation Info/Possible Solution		Field Measurements/Component Compliance	
Severity Score: 25

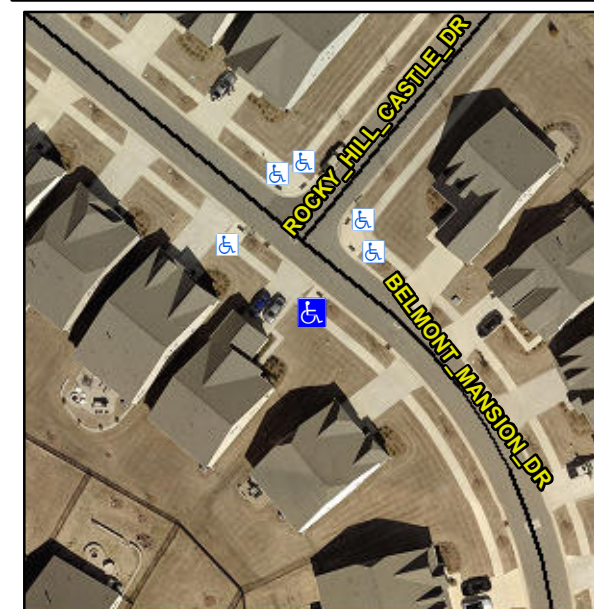
Compliance	Description	Data	Compliance	Description	Data
N/A	Ramp Length (in)	96.0	Yes	BlendTrans Slope (%)	1.9
Yes	Ramp Width (in)	48.0	No	BlendTrans XSlope (%)	7.2
N/A	Flare Type LT	N/A	N/A	Flare Type RT	N/A
N/A	Flare Slope LT (%)	N/A	N/A	Flare Slope RT (%)	N/A
N/A	Flare Traversable LT?	N/A	N/A	Flare Traversable RT?	N/A
N/A	Landing Length (in)	N/A	N/A	DWS Provided?	N/A
N/A	Landing Width (in)	N/A	N/A	DWS Contrast?	N/A
N/A	Landing Slope (%)	N/A	N/A	DWS Length (in)	N/A
N/A	Landing X Slope (%)	N/A	N/A	DWS Full Width?	N/A
N/A	Landing Curb? (Y/N)	N/A	N/A	DWS Offset (in)	N/A
N/A	Shared Landing?	N/A			
N/A	Gutter Ponding?	N/A	N/A	Gutter Slope (%)	N/A
N/A	Gutter Lip Ht (in)	1.0	N/A	Gutter X Slope (%)	N/A
N/A	Painted X Walk1?	No	N/A	Painted X Walk2?	N/A
	X Walk 1 Direction	To NE		X Walk 2 Direction	N/A
	X Walk 1 Width (in)	N/A		X Walk 2 Width (in)	N/A
	X Walk 1 Slope (%)	3.0		X Walk 2 Slope (%)	N/A
	X Walk 1 X Slope (%)	3.9		X Walk 2 X Slope (%)	N/A

N/A	Ramp inside XWalk1?	N/A	N/A	Ramp inside XWalk2?	N/A
	Road Slope (%)	3.9		Clear Space?	N/A
	Road X Slope (%)	3.0	N/A	Clear Space to XWalk (in)	N/A
N/A	Any Obstructions?	N/A	N/A	Storm Grate/Utility Hazard?	N/A
	Obstruction Type			Storm Grate/Utility Type	
		N/A			N/A
			Yes	Surface Condition? (G/P)	Good
			N/A	Curb Slope (%)	2.2

Remove & Replace Curb Ramp With Two New Directional Ramps or Equivalent.

R304.5.3
