# Access Compliance Report

## Public Rights-of-Way

### (Curb Ramps)

Intersection ID: 16598	Main Street: CRAIG_AV	Cross Street: RICHLAND_DR	Location: E
ADA ID: 60A93D50F3BD	Ramp Type: PerpDiag	Initial Pass/Fail: Fail	Overall Compliance: No
Codes/Mitigation Info/Possible Solution		Field Measurements/Component Compliance

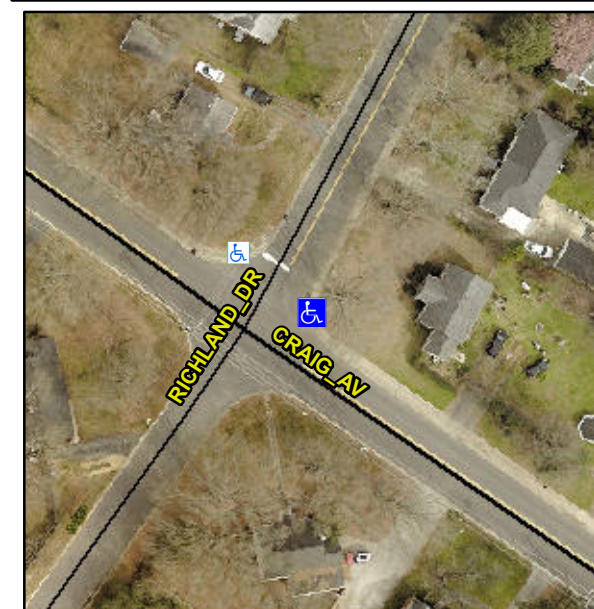
**Not Found, R304.5.1, R304.2.2, R304.5.3**

Compliance	Description	Data	Compliance	Description	Data
N/A	Ramp Length (in)	59.0	No	Ramp Slope (%)	8.9
No	Ramp Width (in)	39.0	No	Ramp XSlope (%)	5.8
N/A	Flare Type LT	N/A	N/A	Flare Type RT	N/A
N/A	Flare Slope LT (%)	N/A	N/A	Flare Slope RT (%)	N/A
N/A	Flare Traversable LT?	N/A	N/A	Flare Traversable RT?	N/A
N/A	Landing Length (in)	N/A	N/A	DWS Provided?	N/A
N/A	Landing Width (in)	N/A	N/A	DWS Contrast?	N/A
N/A	Landing Slope (%)	N/A	N/A	DWS Length (in)	N/A
N/A	Landing X Slope (%)	N/A	N/A	DWS Full Width?	N/A
N/A	Landing Curb? (Y/N)	N/A	N/A	DWS Offset (in)	N/A
N/A	Shared Landing?	N/A			
N/A	Gutter Ponding?	N/A	N/A	Gutter Slope (%)	N/A
N/A	Gutter Lip Ht (in)	N/A	N/A	Gutter X Slope (%)	N/A
N/A	Painted X Walk1?	No	N/A	Painted X Walk2?	No
	X Walk 1 Direction	To SW		X Walk 2 Direction	To NW
N/A	X Walk 1 Width (in)	N/A	N/A	X Walk 2 Width (in)	N/A
	X Walk 1 Slope (%)	0.4		X Walk 2 Slope (%)	6.3
	X Walk 1 X Slope (%)	6.4		X Walk 2 X Slope (%)	0.0

N/A	Ramp inside XWalk1?	N/A	N/A	Ramp inside XWalk2?	N/A
	Road Slope (%)	3.5	N/A	Clear Space?	N/A
	Road X Slope (%)	7.0	N/A	Clear Space to XWalk (in)	N/A
N/A	Any Obstructions?	N/A	N/A	Storm Grate/Utility Hazard?	N/A
	Obstruction Type			Storm Grate/Utility Type	
		N/A			N/A
			Yes	Surface Condition? (G/P)	Good

**Remove & Replace Curb Ramp With Two New Directional Ramps or Equivalent.**

Total Cost: \$ 3200.00
