Access Compliance Report Public Rights-of-Way (Curb Ramps)

Intersection ID: 1745	tersection ID: 17454 Main Street: E_WOODLAWN_RD		Cross	Street:	NATIONS_CROSSING	Location:	SW		
ADA ID: 60B07296E0	0B07296E004 Ramp Type: PerpDiag		Initial I	Initial Pass/Fail: Fail Overall Compliance: No				o Severity Score:	25
Codes/Mitigation Info/Possible Solution				Field Measurements/Component Compliance					
ton		Possible Solutions:						Compliance Description Data

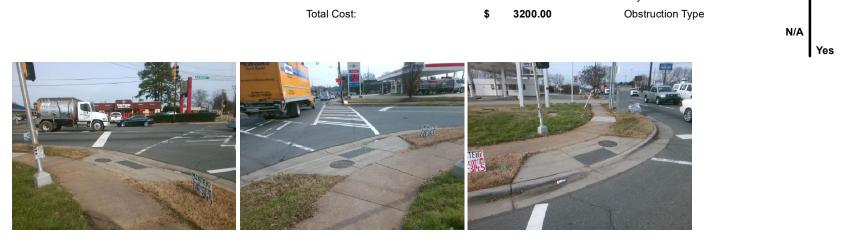
- STREET		Remove & Replace Curb Ramp	With	N/A	Ramp Length (in)	57.0		Ramp Slope (%)	13.2
50		Two New Directional Ramps or		Yes	Ramp Width (in)	48.0	Yes	Ramp XSlope (%)	1.4
		Equivalent.		N/A	Flare Type LT	N/A	N/A	Flare Type RT	N/A
16	E FRANK			N/A	Flare Slope LT (%)	N/A		Flare Slope RT (%)	N/A
	the former			N/A	Flare Traversable LT?	N/A		Flare Traversable RT?	N/A

Street 1 Name	NATIONS CROSSING RD				X Walk 1 Slope (%)	3.1		X Walk 2 Slope (%)	6.0
Stop Condition-Street 2	Signal				X Walk 1 X Slope (%)	3.6		X Walk 2 X Slope (%)	1.5
Street 2 Name	E WOODLAWN RD			N/A	Ramp inside XWalk1?	Yes	N/A	Ramp inside XWalk2?	Yes
Stop Condition-Street 1	Signal				Road Slope (%)	4.2	N/A	Clear Space?	N/A
					Road X Slope (%)	8.0	N/A	Clear Space to XWalk (in)	N/A
				N/A	Any Obstructions?	N/A	N/A	Storm Grate/Utility Hazard?	N/A
		Total Cost: \$	3200.00		Obstruction Type			Storm Grate/Utility Type	
						N/A			N/A

s Surface Condition? (G/P)

Good
