Access Compliance Report

Public Rights-of-Way

(Curb Ramps)

Intersection ID: 12393	Main Street: FRIAR_ST	Cross Street: WESTERLY_HILLS_DR	Location: SW
ADA ID: 60B2CD7C9DC1	Ramp Type: Perp	Initial Pass/Fail: Fail	Overall Compliance: No
			Severity Score: 13.75

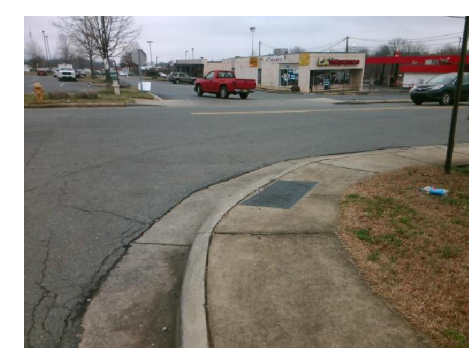
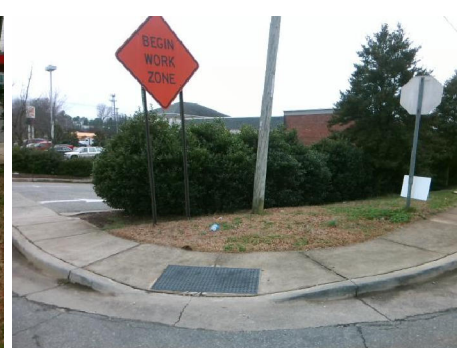
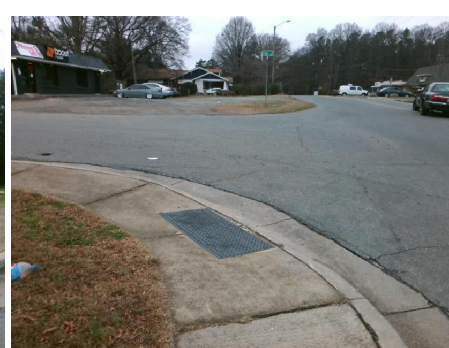
Possible Solutions:		Compliance	Description	Data
	Remove & Replace Entire Ramp.		No	Ramp Length (in)	48.0
			Yes	Ramp Width (in)	48.0
			N/A	Flare Type LT	N/A
			N/A	Flare Slope LT (%)	N/A
			N/A	Flare Traversable LT?	N/A
			N/A	Landing Length (in)	N/A
			N/A	Landing Width (in)	N/A
			N/A	Landing Slope (%)	N/A
			N/A	Landing X Slope (%)	N/A
<p>Surveyor Notes:</p> <p>N/A</p> <p>PROW/ADA:</p> <p>Not Found, R304.2.2, R304.5.3</p>			N/A	Flare Type RT	N/A
			N/A	Flare Slope RT (%)	N/A
			N/A	Flare Traversable RT?	N/A
			N/A	DWS Provided?	N/A
			N/A	DWS Contrast?	N/A
			N/A	DWS Length (in)	N/A
			N/A	DWS Full Width?	N/A
			N/A	DWS Offset (in)	N/A
			N/A	Shared Landing?	N/A
			N/A	Gutter Ponding?	N/A
			N/A	Gutter Lip Ht (in)	N/A
			N/A	Painted X Walk1?	No
				X Walk 1 Direction	To N
			N/A	X Walk 1 Width (in)	N/A
				X Walk 1 Slope (%)	4.1

X Walk 1 X Slope (%)	4.7
			N/A	Ramp inside XWalk1?	N/A
				Road Slope (%)	4.7
				Road X Slope (%)	4.1
			N/A	Any Obstructions?	N/A
				Obstruction Type	
Total Cost:		\$ 1850.00			
			N/A		N/A
			Yes	Surface Condition? (G/P)	Good
