Access Compliance Report

Public Rights-of-Way

(Curb Ramps)

Intersection ID: N/A	Main Street: NORTHLAKE CENTRE PY	Cross Street: N/A	Location: NW
ADA ID: 60C064FA1FC4	Ramp Type: PerpDiag	Initial Pass/Fail: Pass	Overall Compliance: No
		Severity Score: 0

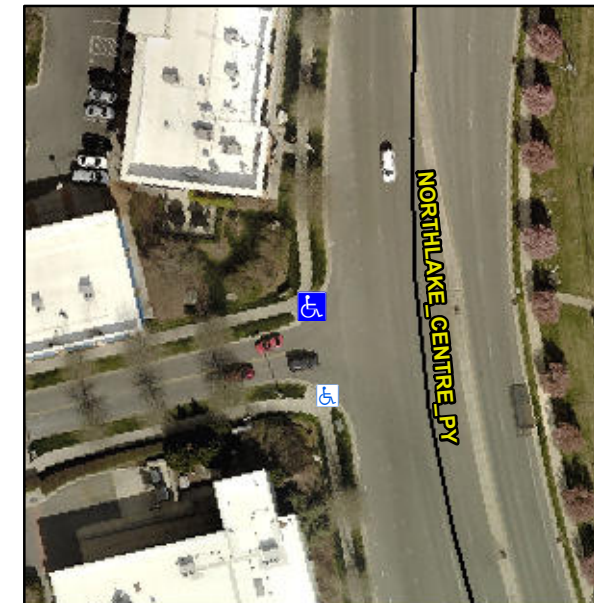
Not Found, R304.2.1, R304.2.2-Perp, R304.3.2-Para, R305.2

Compliance	Description	Data	Compliance	Description	Data
N/A	Ramp Length (in)	53.0	Yes	Ramp Slope (%)	6.6
Yes	Ramp Width (in)	50.0	Yes	Ramp XSlope (%)	0.9
N/A	Flare Type LT	Sloped	N/A	Flare Type RT	N/A
N/A	Flare Slope LT (%)	5.3	N/A	Flare Slope RT (%)	5.0
N/A	Flare Traversable LT?	No	N/A	Flare Traversable RT?	No
Yes	Landing Length (in)	70.0	Yes	DWS Provided?	Yes
No	Landing Width (in)	38.0	Yes	DWS Contrast?	Yes
No	Landing Slope (%)	2.2	Yes	DWS Length (in)	24.0
Yes	Landing X Slope (%)	0.7	Yes	DWS Full Width?	Yes
N/A	Landing Curb? (Y/N)	No	No	DWS Offset (in)	4.5
N/A	Shared Landing?	No			
Yes	Gutter Ponding?	No	Yes	Gutter Slope (%)	0.9
Yes	Gutter Lip Ht (in)	0.0	Yes	Gutter X Slope (%)	0.1
N/A	Painted X Walk1?	No	N/A	Painted X Walk2?	No
	X Walk 1 Direction	To S		X Walk 2 Direction	To E
N/A	X Walk 1 Width (in)	N/A	N/A	X Walk 2 Width (in)	N/A
	X Walk 1 Slope (%)	3.7		X Walk 2 Slope (%)	3.2
	X Walk 1 X Slope (%)	2.1		X Walk 2 X Slope (%)	4.1

N/A	Ramp inside XWalk1?	N/A	N/A	Ramp inside XWalk2?	N/A
	Road Slope (%)	0.8	N/A	Clear Space?	Yes
	Road X Slope (%)	1.9	N/A	Clear Space to XWalk (in)	N/A
Yes	Any Obstructions?	No	Yes	Storm Grate/Utility Hazard?	No
	Obstruction Type			Storm Grate/Utility Type	
		N/A			N/A
			Yes	Surface Condition? (G/P)	Good

Remove & Replace Curb Ramp With Two New Directional Ramps or Equivalent.
