# Access Compliance Report

## Public Rights-of-Way

### (Curb Ramps)

Intersection ID: 27163	Main Street: HEATHERTON_PL	Cross Street: PROVIDENCE_ARBOURS_DR	Location: NW
ADA ID: 60CF28D92BC8	Ramp Type: Perp	Initial Pass/Fail: Fail	Overall Compliance: No
		Severity Score: 25

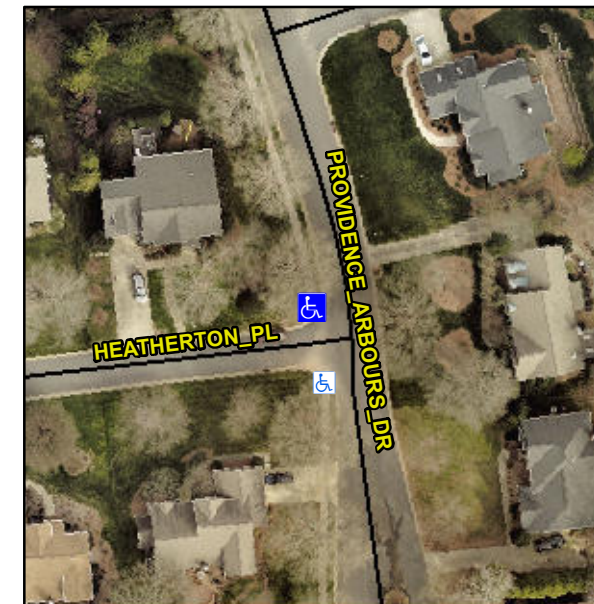
Compliance	Description	Data	Compliance	Description	Data
N/A	Ramp Length (in)	46.5	Yes	Ramp Slope (%)	7.0
Yes	Ramp Width (in)	74.0	No	Ramp XSlope (%)	7.1
N/A	Flare Type LT	N/A	N/A	Flare Type RT	N/A
N/A	Flare Slope LT (%)	N/A	N/A	Flare Slope RT (%)	N/A
N/A	Flare Traversable LT?	N/A	N/A	Flare Traversable RT?	N/A
N/A	Landing Length (in)	N/A	N/A	DWS Provided?	N/A
N/A	Landing Width (in)	N/A	N/A	DWS Contrast?	N/A
N/A	Landing Slope (%)	N/A	N/A	DWS Length (in)	N/A
N/A	Landing X Slope (%)	N/A	N/A	DWS Full Width?	N/A
N/A	Landing Curb? (Y/N)	N/A	N/A	DWS Offset (in)	N/A
N/A	Shared Landing?	N/A			
N/A	Gutter Ponding?	N/A	N/A	Gutter Slope (%)	N/A
N/A	Gutter Lip Ht (in)	N/A	N/A	Gutter X Slope (%)	N/A
N/A	Painted X Walk1?	No	N/A	Painted X Walk2?	N/A
	X Walk 1 Direction	To S		X Walk 2 Direction	N/A
N/A	X Walk 1 Width (in)	N/A	N/A	X Walk 2 Width (in)	N/A
	X Walk 1 Slope (%)	6.2		X Walk 2 Slope (%)	N/A
	X Walk 1 X Slope (%)	0.2		X Walk 2 X Slope (%)	N/A

N/A	Ramp inside XWalk1?	N/A	N/A	Ramp inside XWalk2?	N/A
	Road Slope (%)	N/A	N/A	Clear Space?	N/A
	Road X Slope (%)	N/A	N/A	Clear Space to XWalk (in)	N/A
N/A	Any Obstructions?	N/A	N/A	Storm Grate/Utility Hazard?	N/A
	Obstruction Type			Storm Grate/Utility Type	
		N/A			N/A
			Yes	Surface Condition? (G/P)	Good

**Remove & Replace Entire Ramp.**

**Not Found, R304.5.3**
