# Access Compliance Report

## Public Rights-of-Way

### (Curb Ramps)

Intersection ID: 10033353	Main Street: OHAUS_CT	Cross Street: N/A	Location: E
ADA ID: 60CF32D19526	Ramp Type: Perp	Initial Pass/Fail: Fail	Overall Compliance: No
			Severity Score: 13.75

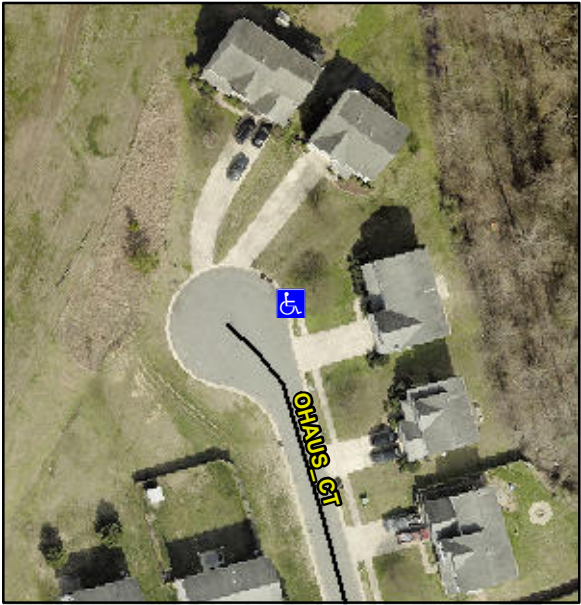
Possible Solutions:		<b>Compliance</b>	<b>Description</b>	<b>Data</b>
	<b>Remove &amp; Replace Entire Ramp.</b>		<b>No</b>	Ramp Length (in)	43.5
			<b>Yes</b>	Ramp Width (in)	48.0
			<b>N/A</b>	Flare Type LT	N/A
			<b>N/A</b>	Flare Slope LT (%)	N/A
			<b>N/A</b>	Flare Traversable LT?	N/A
			<b>N/A</b>	Landing Length (in)	N/A
			<b>N/A</b>	Landing Width (in)	N/A
			<b>N/A</b>	Landing Slope (%)	N/A
			<b>N/A</b>	Landing X Slope (%)	N/A
<p>Surveyor Notes:</p> <p><b>N/A</b></p>			<b>N/A</b>	Landing Curb? (Y/N)	N/A
			<b>N/A</b>	Shared Landing?	N/A
			<b>N/A</b>	Gutter Ponding?	N/A
			<b>N/A</b>	Gutter Lip Ht (in)	N/A
			<b>N/A</b>	Painted X Walk1?	No
				X Walk 1 Direction	To W
			<b>N/A</b>	X Walk 1 Width (in)	N/A
				X Walk 1 Slope (%)	4.0
				X Walk 1 X Slope (%)	3.6
			<b>N/A</b>	Ramp inside XWalk1?	N/A
<p>PROW/ADA:</p> <p><b>Not Found, R304.2.2, R304.5.3</b></p>			<b>N/A</b>	Road Slope (%)	3.6

Road X Slope (%)	4.0
			<b>N/A</b>	Any Obstructions?	N/A
				Obstruction Type	
			<b>N/A</b>		
			<b>N/A</b>		
			<b>N/A</b>		
			<b>N/A</b>		
			<b>N/A</b>		
			<b>N/A</b>		
<p>Total Cost:</p> <p><b>\$ 1850.00</b></p>			<b>N/A</b>	Storm Grate/Utility Hazard?	N/A
				Storm Grate/Utility Type	
			<b>N/A</b>		
			<b>N/A</b>		
			<b>N/A</b>		
			<b>N/A</b>		
			<b>N/A</b>		
			<b>N/A</b>		
			<b>N/A</b>		
			<b>N/A</b>		
<p>Street 1 Name</p> <p><b>OHAUS CT</b></p> <p>Stop Condition-Street 2</p> <p><b>None</b></p> <p>Street 2 Name</p> <p><b>N/A</b></p> <p>Stop Condition-Street 1</p> <p><b>N/A</b></p>			<b>Yes</b>	Surface Condition? (G/P)	<b>Good</b>
