# Access Compliance Report

## Public Rights-of-Way

### (Curb Ramps)

| Intersection ID: 17409 | Main Street: HILLSIDE_AV | Cross Street: PARK_RD | Location: NW |

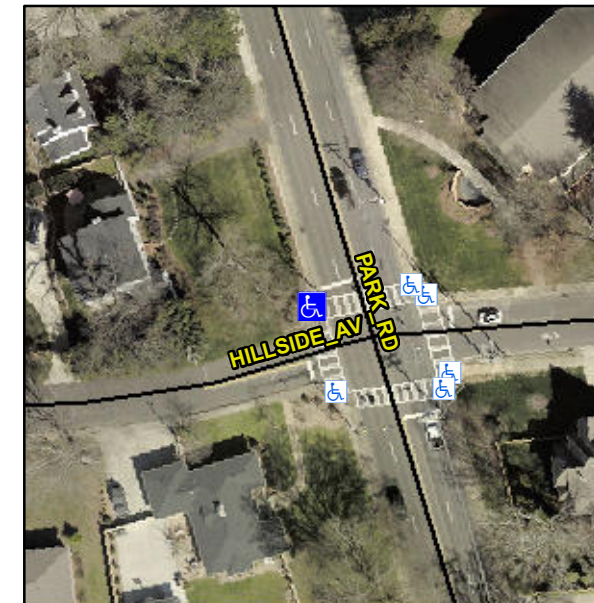
| ADA ID: 60E2F3BBEFFF | Ramp Type: PerpDiag | Initial Pass/Fail: Pass | Overall Compliance: No |
| | | Severity Score: 10 | |

**R304.2.1, R304.2.2-Perp, R304.3.2-Para, R304.5.3, R305.2**

| Compliance | Description | Data | Compliance | Description | Data |
|---|---|---|---|---|---|
| No | Landing Length (in) | N/A | Yes | DWS Provided? | Yes |
| No | Landing Width (in) | N/A | Yes | DWS Contrast? | Yes |
| No | Landing Slope (%) | N/A | Yes | DWS Length (in) | 25.0 |
| No | Landing X Slope (%) | N/A | Yes | DWS Full Width? | Yes |
| N/A | Landing Curb? (Y/N) | No | No | DWS Offset (in) | 4.0 |

**Remove & Replace Curb Ramp With Two New Directional Ramps or Equivalent.**

Total Cost: \$ 3200.00
