Access Compliance Report

Public Rights-of-Way

(Curb Ramps)

Intersection ID: 29985	Main Street: NELAND_LN	Cross Street: WINDING_RIVER_DR	Location: S
ADA ID: 60E73649CF77	Ramp Type: Perp	Initial Pass/Fail: Fail	Overall Compliance: No
Severity Score: 33.75			
Codes/Mitigation Info/Possible Solution		Field Measurements/Component Compliance

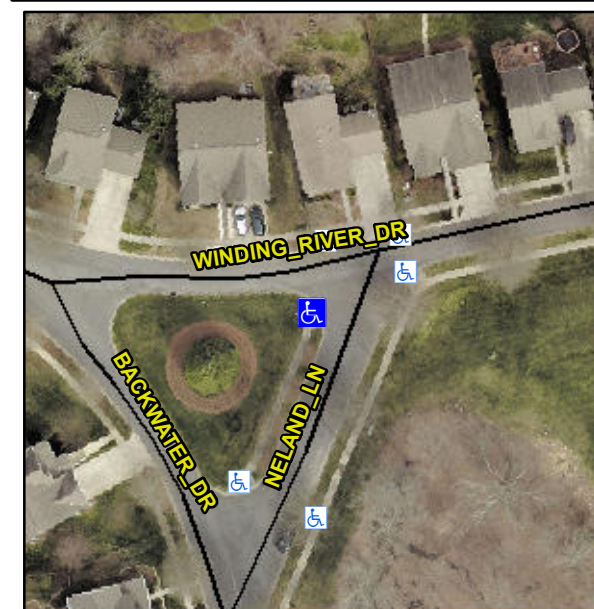
Not Found, R304.5.1, R304.5.3

Compliance	Description	Data	Compliance	Description	Data
N/A	Ramp Length (in)	72.0	Yes	Ramp Slope (%)	5.0
No	Ramp Width (in)	47.5	No	Ramp XSlope (%)	14.0
N/A	Flare Type LT	N/A	N/A	Flare Type RT	N/A
N/A	Flare Slope LT (%)	N/A	N/A	Flare Slope RT (%)	N/A
N/A	Flare Traversable LT?	N/A	N/A	Flare Traversable RT?	N/A
N/A	Landing Length (in)	N/A	N/A	DWS Provided?	N/A
N/A	Landing Width (in)	N/A	N/A	DWS Contrast?	N/A
N/A	Landing Slope (%)	N/A	N/A	DWS Length (in)	N/A
N/A	Landing X Slope (%)	N/A	N/A	DWS Full Width?	N/A
N/A	Landing Curb? (Y/N)	N/A	N/A	DWS Offset (in)	N/A
N/A	Shared Landing?	N/A			
N/A	Gutter Ponding?	N/A	N/A	Gutter Slope (%)	N/A
N/A	Gutter Lip Ht (in)	N/A	N/A	Gutter X Slope (%)	N/A
N/A	Painted X Walk1?	No	N/A	Painted X Walk2?	N/A
	X Walk 1 Direction	To NE		X Walk 2 Direction	N/A
N/A	X Walk 1 Width (in)	N/A	N/A	X Walk 2 Width (in)	N/A
	X Walk 1 Slope (%)	1.4		X Walk 2 Slope (%)	N/A
	X Walk 1 X Slope (%)	8.1		X Walk 2 X Slope (%)	N/A

N/A	Ramp inside XWalk1?	N/A	N/A	Ramp inside XWalk2?	N/A
	Road Slope (%)	N/A	N/A	Clear Space?	N/A
	Road X Slope (%)	N/A	N/A	Clear Space to XWalk (in)	N/A
N/A	Any Obstructions?	N/A	N/A	Storm Grate/Utility Hazard?	N/A
	Obstruction Type			Storm Grate/Utility Type	
		N/A			N/A
			Yes	Surface Condition? (G/P)	Good

Possible Solutions:

Remove & Replace Entire Ramp.
