Access Compliance Report

Public Rights-of-Way

(Curb Ramps)

Intersection ID: 8684	Main Street: CENTRE_ST	Cross Street: DARBY_AV	Location: S
ADA ID: 60F6421F914D	Ramp Type: Perp	Initial Pass/Fail: Fail	Overall Compliance: No
		Severity Score: 10

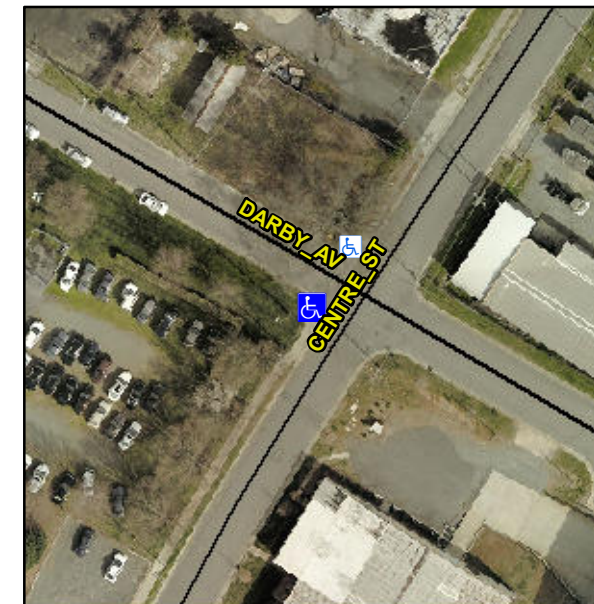
Not Found, R304.5.1, R304.5.3

Compliance	Description	Data	Compliance	Description	Data
N/A	Ramp Length (in)	74.0	Yes	Ramp Slope (%)	6.6
No	Ramp Width (in)	47.5	No	Ramp XSlope (%)	4.9
N/A	Flare Type LT	N/A	N/A	Flare Type RT	N/A
N/A	Flare Slope LT (%)	N/A	N/A	Flare Slope RT (%)	N/A
N/A	Flare Traversable LT?	N/A	N/A	Flare Traversable RT?	N/A
N/A	Landing Length (in)	N/A	N/A	DWS Provided?	N/A
N/A	Landing Width (in)	N/A	N/A	DWS Contrast?	N/A
N/A	Landing Slope (%)	N/A	N/A	DWS Length (in)	N/A
N/A	Landing X Slope (%)	N/A	N/A	DWS Full Width?	N/A
N/A	Landing Curb? (Y/N)	N/A	N/A	DWS Offset (in)	N/A
N/A	Shared Landing?	N/A			
N/A	Gutter Ponding?	N/A	N/A	Gutter Slope (%)	N/A
N/A	Gutter Lip Ht (in)	N/A	N/A	Gutter X Slope (%)	N/A
N/A	Painted X Walk1?	No	N/A	Painted X Walk2?	N/A
	X Walk 1 Direction	To NE		X Walk 2 Direction	N/A
N/A	X Walk 1 Width (in)	N/A	N/A	X Walk 2 Width (in)	N/A
	X Walk 1 Slope (%)	4.8		X Walk 2 Slope (%)	N/A
	X Walk 1 X Slope (%)	1.7		X Walk 2 X Slope (%)	N/A

Remove & Replace Entire Ramp.

Total Cost: \$ 1850.00
