| Intersection ID: 32090 | Main Street: JERPOINT_ABBY_DR | Cross Street: RATHANGAN_DR | Location: | NE |
| ADA ID: 60FAF023F446 | Ramp Type: PerpDiag | Initial Pass/Fail: Fail | Overall Compliance: No | Severity Score: 25 |

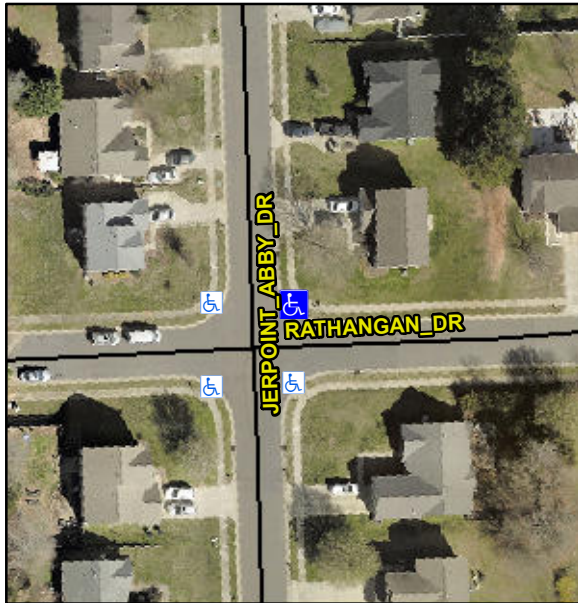
| Codes/Mitigation Info/Possible Solution | Field Measurements/Component Compliance |

**Remove & Replace Curb Ramp With Two New Directional Ramps or Equivalent.**

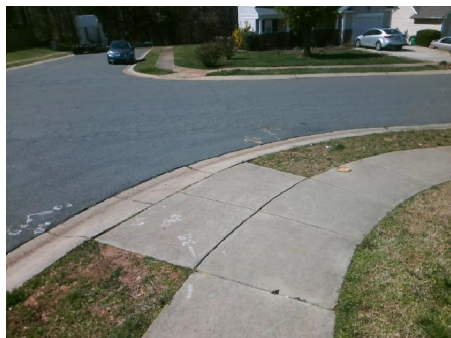
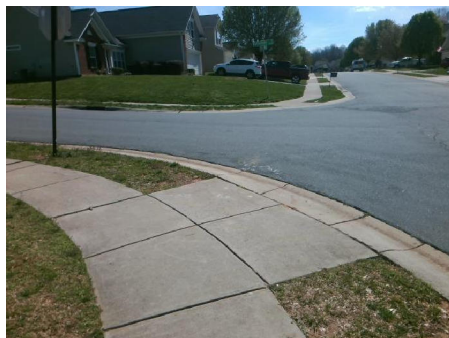
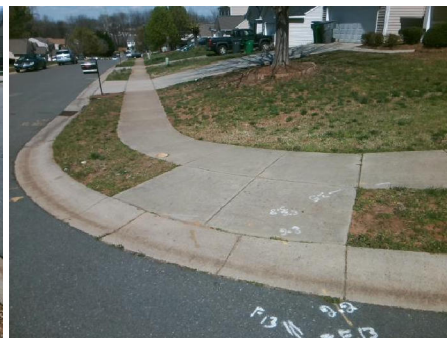
| Compliance | Description | Data | Compliance | Description | Data |
|---|---|---|---|---|---|
| Yes | Ramp Width (in) | 48.0 | No | Ramp XSlope (%) | 7.1 |

### R304.5.3

Total Cost: \$ 3200.00
