Access Compliance Report

Public Rights-of-Way

(Curb Ramps)

Intersection ID: 16132	Main Street: S_TRYON_ST	Cross Street: W_CAMA_ST	Location: NW
ADA ID: 6102926FC193	Ramp Type: PerpDiag	Initial Pass/Fail: Fail	Overall Compliance: No
Severity Score: 10			
Codes/Mitigation Info/Possible Solution		Field Measurements/Component Compliance

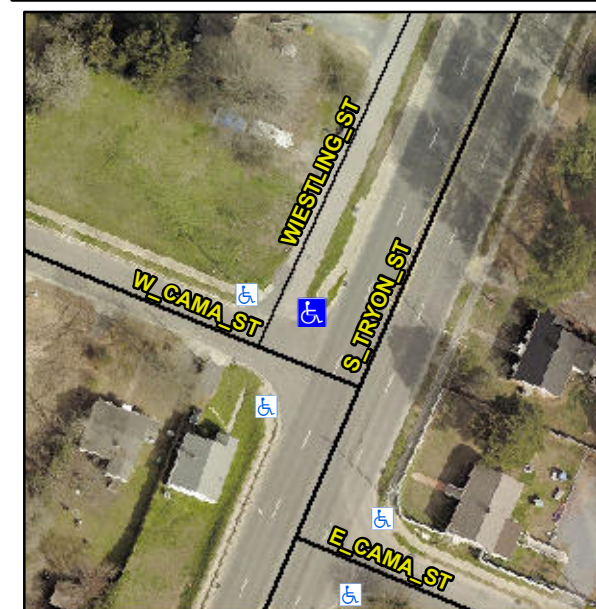
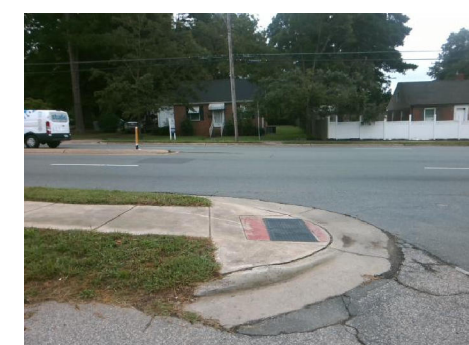
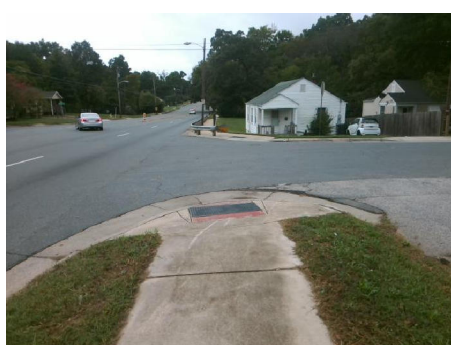
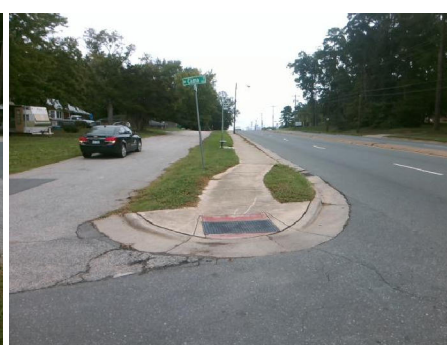
Compliance	Description	Data	Compliance	Description	Data
N/A	Ramp Length (in)	69.0	Yes	Ramp Slope (%)	5.8
No	Ramp Width (in)	47.0	No	Ramp XSlope (%)	2.6
N/A	Flare Type LT	N/A	N/A	Flare Type RT	N/A
N/A	Flare Slope LT (%)	N/A	N/A	Flare Slope RT (%)	N/A
N/A	Flare Traversable LT?	N/A	N/A	Flare Traversable RT?	N/A
N/A	Landing Length (in)	N/A	N/A	DWS Provided?	N/A
N/A	Landing Width (in)	N/A	N/A	DWS Contrast?	N/A
N/A	Landing Slope (%)	N/A	N/A	DWS Length (in)	N/A
N/A	Landing X Slope (%)	N/A	N/A	DWS Full Width?	N/A
N/A	Landing Curb? (Y/N)	N/A	N/A	DWS Offset (in)	N/A
N/A	Shared Landing?	N/A			
N/A	Gutter Ponding?	N/A	N/A	Gutter Slope (%)	N/A
N/A	Gutter Lip Ht (in)	N/A	N/A	Gutter X Slope (%)	N/A
N/A	Painted X Walk1?	No	N/A	Painted X Walk2?	No
	X Walk 1 Direction	To SW		X Walk 2 Direction	To SE
N/A	X Walk 1 Width (in)	N/A	N/A	X Walk 2 Width (in)	N/A
	X Walk 1 Slope (%)	0.9		X Walk 2 Slope (%)	1.8
	X Walk 1 X Slope (%)	0.1		X Walk 2 X Slope (%)	0.9

N/A	Ramp inside XWalk1?	N/A	N/A	Ramp inside XWalk2?	N/A
	Road Slope (%)	0.4	N/A	Clear Space?	N/A
	Road X Slope (%)	1.6	N/A	Clear Space to XWalk (in)	N/A
N/A	Any Obstructions?	N/A	N/A	Storm Grate/Utility Hazard?	N/A
	Obstruction Type			Storm Grate/Utility Type	
		N/A			N/A
			Yes	Surface Condition? (G/P)	Good

Remove & Replace Curb Ramp With Two New Directional Ramps or Equivalent.

R304.5.1, R304.5.3
