# Access Compliance Report

## Public Rights-of-Way

| Intersection ID: 11540 | Main Street: W MARTIN LUTHER KING JR BV | Access Street: S SUMMIT AV | Location: E |
| ADA ID: 61056EBB1C21 | Ramp Type: Directional | Initial Pass/Fail: Pass | Overall Compliance: No |

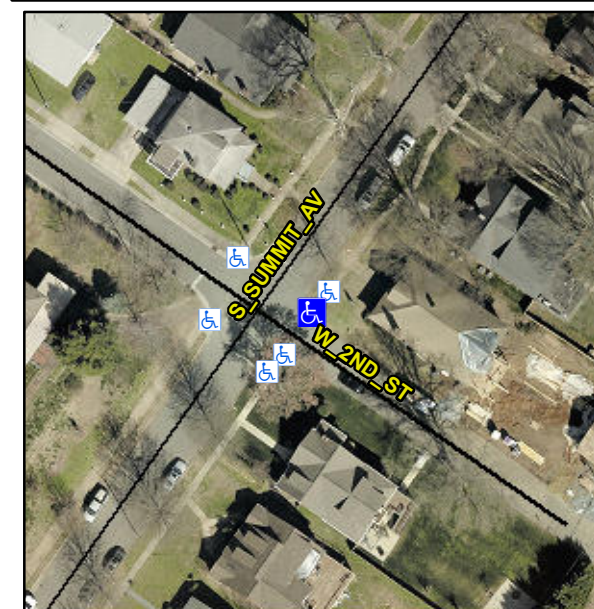
| Severity Score: 17.5 | | | |

| Compliance | Description | Data | Compliance | Description | Data |
|---|---|---|---|---|---|
| N/A | Ramp Length (in) | 61.0 | No | Grade Break? | No |
| Yes | Landing Length (in) | 61.0 | No | DWS Provided? | No |
| No | Landing Slope (%) | 4.7 | N/A | DWS Length (in) | N/A |
| No | Gutter Lip Ht (in) | 0.5 | Yes | Gutter X Slope (%) | 1.7 |

**Remove & Replace Entire Ramp.  
Grind Gutter Lip.**

**R304.2.2-Perp, R304.3.2-Para,  
R304.5.2, R305, R302.7.2**

Total Cost: \$ 1800.00

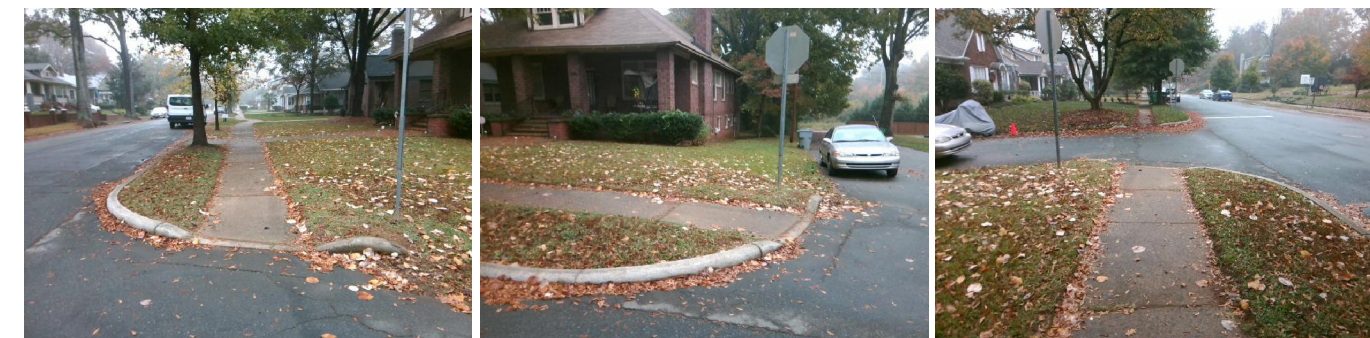
Street 1 Name MARTIN LUTHER LING JR BV  
 Stop Condition-Street 1 StopSign  
 Street 2 Name N/A  
 Stop Condition-Street 2 N/A
