Intersection ID: N/A	Main Street: COVENTRY_COURT_LN	Cross Street: CASTLE_ABBEY_LN	Location:	SW
ADA ID: 610899F3710D	Ramp Type: ParaDiag	Initial Pass/Fail: Fail	Overall Compliance: No	Severity Score: 13.75

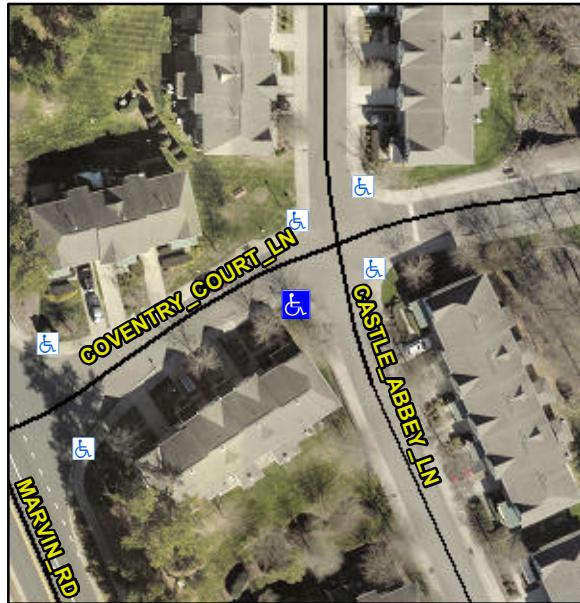
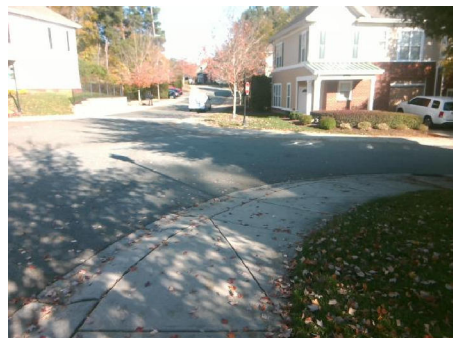
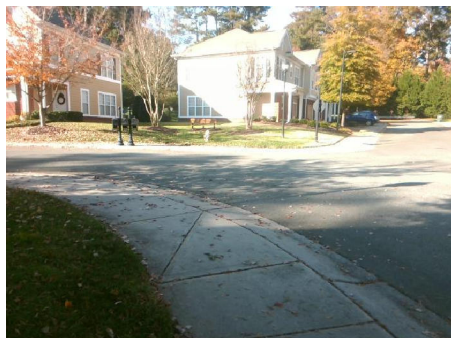
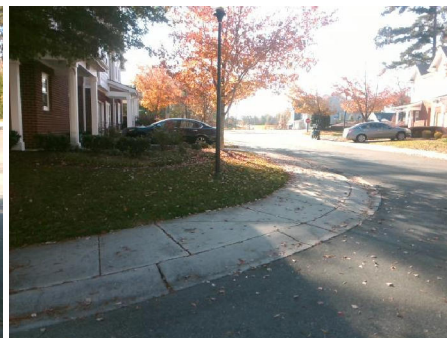
LT RP < 5%

Compliance	Description	Data	Compliance	Description	Data
N/A	Ramp Length LT (in)	32.0	N/A	Ramp Length RT (in)	39.0
Yes	Ramp Width LT (in)	60.0	Yes	Ramp Width RT (in)	60.0
Yes	Ramp Slope LT (%)	1.6	No	Ramp Slope RT (%)	9.1
No	Ramp XSlope LT (%)	2.3	No	Ramp XSlope RT (%)	3.0
N/A	Landing Length (in)	N/A	N/A	DWS Provided?	N/A
N/A	Landing Width (in)	N/A	N/A	DWS Contrast?	N/A
N/A	Landing Slope (%)	N/A	N/A	DWS Length (in)	N/A
N/A	Landing X Slope (%)	N/A	N/A	DWS Full Width?	N/A
N/A	Landing Curb? (Y/N)	N/A	N/A	DWS Offset (in)	N/A
N/A	Shared Landing?	N/A			
N/A	Gutter Ponding?	N/A	N/A	Gutter Slope (%)	N/A
N/A	Gutter Lip Ht (in)	N/A	N/A	Gutter X Slope (%)	N/A
N/A	Painted X Walk1?	No	N/A	Painted X Walk2?	No
	X Walk 1 Direction	To E		X Walk 2 Direction	To N
N/A	X Walk 1 Width (in)	N/A	N/A	X Walk 2 Width (in)	N/A
	X Walk 1 Slope (%)	1.6		X Walk 2 Slope (%)	4.1
	X Walk 1 X Slope (%)	4.4		X Walk 2 X Slope (%)	2.7
N/A	Ramp inside XWalk1?	N/A	N/A	Ramp inside XWalk2?	N/A

Road Slope (%)	3.9	N/A	Clear Space?	N/A
	Road X Slope (%)	2.7	N/A	Clear Space to XWalk (in)	N/A
N/A	Any Obstructions?	N/A	N/A	Storm Grate/Utility Hazard?	N/A
	Obstruction Type			Storm Grate/Utility Type	
		N/A			N/A
			Yes	Surface Condition? (G/P)	Good
			N/A	Curb Slope (%)	16.6

Possible Solutions:

Remove & Replace Curb Ramp With Two New Directional Ramps or Equivalent.
