Access Compliance Report

Public Rights-of-Way

(Curb Ramps)

Intersection ID: 11775	Main Street: E_18TH_ST	Cross Street: SEIGLE_AV	Location: E
ADA ID: 610C474FC17B	Ramp Type: Perp	Initial Pass/Fail: Fail	Overall Compliance: No
		Severity Score: 8.75

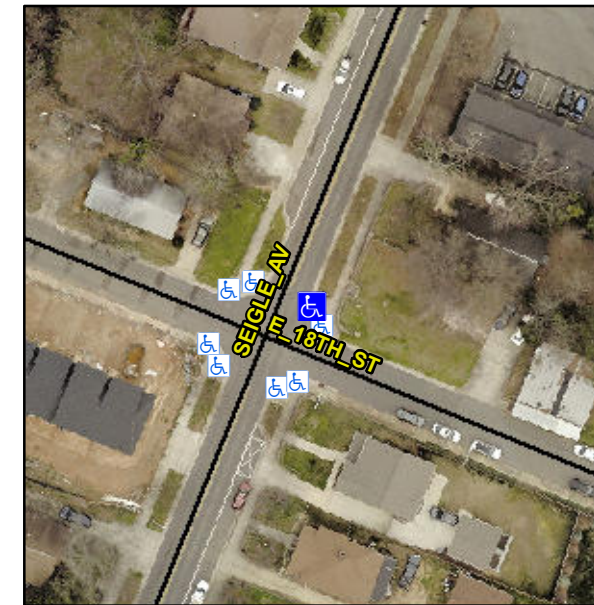
Compliance	Description	Data	Compliance	Description	Data
N/A	Ramp Length (in)	70.0	Yes	Ramp Slope (%)	5.8
No	Ramp Width (in)	47.5	Yes	Ramp XSlope (%)	1.7
N/A	Flare Type LT	N/A	N/A	Flare Type RT	N/A
N/A	Flare Slope LT (%)	N/A	N/A	Flare Slope RT (%)	N/A
N/A	Flare Traversable LT?	N/A	N/A	Flare Traversable RT?	N/A
N/A	Landing Length (in)	N/A	N/A	DWS Provided?	N/A
N/A	Landing Width (in)	N/A	N/A	DWS Contrast?	N/A
N/A	Landing Slope (%)	N/A	N/A	DWS Length (in)	N/A
N/A	Landing X Slope (%)	N/A	N/A	DWS Full Width?	N/A
N/A	Landing Curb? (Y/N)	N/A	N/A	DWS Offset (in)	N/A
N/A	Shared Landing?	N/A			
N/A	Gutter Ponding?	Yes	N/A	Gutter Slope (%)	N/A
N/A	Gutter Lip Ht (in)	N/A	N/A	Gutter X Slope (%)	N/A
N/A	Painted X Walk1?	No	N/A	Painted X Walk2?	N/A
	X Walk 1 Direction	To NW		X Walk 2 Direction	N/A
N/A	X Walk 1 Width (in)	N/A	N/A	X Walk 2 Width (in)	N/A
	X Walk 1 Slope (%)	0.5		X Walk 2 Slope (%)	N/A
	X Walk 1 X Slope (%)	0.1		X Walk 2 X Slope (%)	N/A

N/A	Ramp inside XWalk1?	N/A	N/A	Ramp inside XWalk2?	N/A
	Road Slope (%)	N/A	N/A	Clear Space?	N/A
	Road X Slope (%)	N/A	N/A	Clear Space to XWalk (in)	N/A
N/A	Any Obstructions?	N/A	N/A	Storm Grate/Utility Hazard?	N/A
	Obstruction Type			Storm Grate/Utility Type	
		N/A			N/A
		Yes		Surface Condition? (G/P)	Good

Possible Solutions:

Remove & Replace Entire Ramp.

R304.5.1

\$ 1850.00
