# Access Compliance Report

## Public Rights-of-Way

### (Curb Ramps)

Intersection ID: 43119	Main Street: BELLE_TERRE_AV	Cross Street: THOMAS_AV	Location: W
ADA ID: 611958CAA2D0	Ramp Type: Directional1	Initial Pass/Fail: Fail	Overall Compliance: No
Severity Score: 1.25			
Codes/Mitigation Info/Possible Solution		Field Measurements/Component Compliance

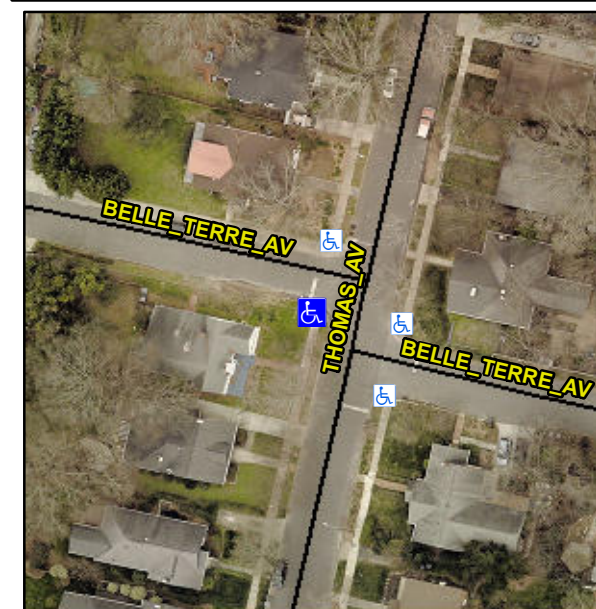
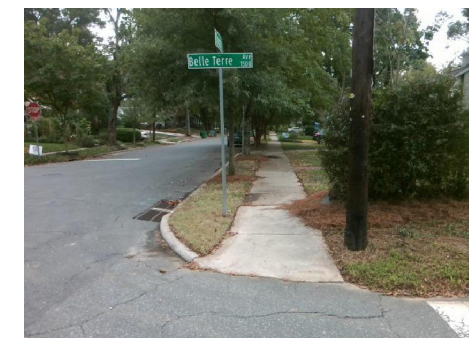
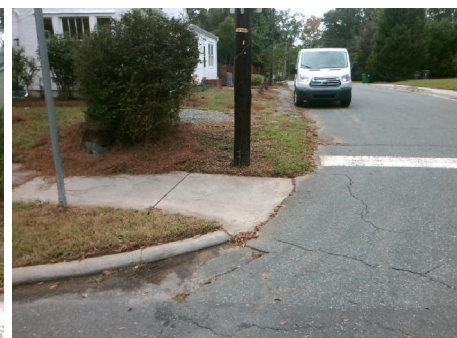
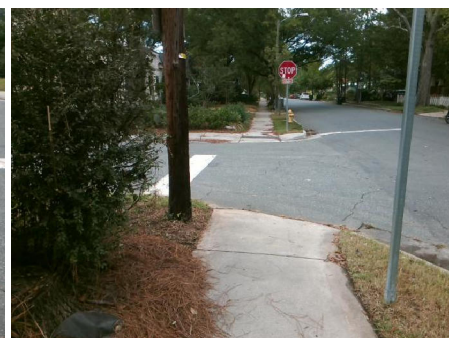
Compliance	Description	Data	Compliance	Description	Data
N/A	Ramp Length (in)	48.0	N/A	Grade Break?	N/A
Yes	Ramp Width (in)	60.0	N/A	Grade Break Slope (%)	0.0
Yes	Ramp Slope (%)	6.9	N/A	Grade Break XSlope (%)	0.0
No	Ramp XSlope (%)	3.4			
N/A	Flare Type LT	N/A	N/A	Flare Type RT	N/A
N/A	Flare Slope LT (%)	N/A	N/A	Flare Slope RT (%)	0.0
N/A	Flare Traversable LT?	N/A	N/A	Flare Traversable RT?	N/A
N/A	Landing Length (in)	0.0	N/A	DWS Provided?	N/A
N/A	Landing Width (in)	0.0	N/A	DWS Contrast?	N/A
N/A	Landing Slope (%)	0.0	N/A	DWS Length (in)	N/A
N/A	Landing X Slope (%)	0.0	N/A	DWS Full Width?	N/A
N/A	Landing Curb? (Y/N)	N/A	N/A	DWS Offset LT (in)	N/A
N/A	Shared Landing?	N/A	N/A	DWS Offset RT (in)	N/A
N/A	Gutter Ponding?	0.0	N/A	Gutter Slope (%)	N/A
N/A	Gutter Lip Ht (in)	0.0	N/A	Gutter X Slope (%)	N/A
N/A	Painted X Walk1?	No		Road Slope (%)	4.6
	X Walk 1 Direction	To N		Road X Slope (%)	3.1
	X Walk 1 Width (in)	N/A		Clear Space?	N/A

X Walk 1 Slope (%)	4.6	N/A	Clear Space to XWalk (in)	N/A
	X Walk 1 X Slope (%)	3.1	N/A	Storm Grate/Utility Hazard?	N/A
N/A	Ramp inside XWalk1?	N/A		Storm Grate/Utility Type	
N/A	Any Obstructions?	N/A			N/A
	Obstruction Type		Yes	Surface Condition? (G/P)	Good
			N/A	Curb Slope (%)	0.1

Possible Solutions:

**Remove & Replace Entire Ramp.**

**R304.5.3**
