## Access Compliance Report Public Rights-of-Way (Curb Ramps)

Intersection ID: 14249Main Street: E\_3RD\_STCross Street: QUEENS\_RDLocation: WADA ID: 611AC14514C5Ramp Type: PerpDiagInitial Pass/Fail: Fail Overall Compliance: No Severity Score: 33.75

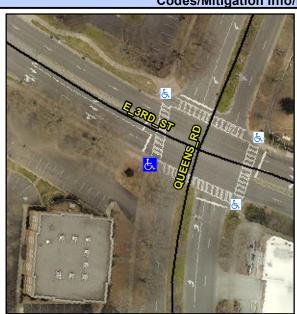
Field Measurements/Component Compilance					
Compliance Description		Data	Compliance Description		Data
N/A	Ramp Length (in)	59.0	No	Ramp Slope (%)	14.0
No	Ramp Width (in)	41.0	Yes	Ramp XSlope (%)	1.3
N/A	Flare Type LT	N/A	N/A	Flare Type RT	N/A
N/A	Flare Slope LT (%)	N/A	N/A	Flare Slope RT (%)	N/A
N/A	Flare Traversable LT?	N/A	N/A	Flare Traversable RT?	N/A
N/A	Landing Length (in)	N/A	N/A	DWS Provided?	N/A
N/A	Landing Width (in)	N/A	N/A	DWS Contrast?	N/A
N/A	Landing Slope (%)	N/A	N/A	DWS Length (in)	N/A
N/A	Landing X Slope (%)	N/A	N/A	DWS Full Width?	N/A
N/A	Landing Curb? (Y/N)	N/A	N/A	DWS Offset (in)	N/A
N/A	Shared Landing?	N/A			
N/A	Gutter Ponding?	N/A	N/A	Gutter Slope (%)	N/A
N/A	Gutter Lip Ht (in)	1.0	N/A	Gutter X Slope (%)	N/A
N/A	Painted X Walk1?	Yes	N/A	Painted X Walk2?	Yes
	X Walk 1 Direction	To SE		X Walk 2 Direction	To NE
N/A	X Walk 1 Width (in)	100.0	N/A	X Walk 2 Width (in)	104.0
	X Walk 1 Slope (%)	3.2		X Walk 2 Slope (%)	4.4

X Walk 1 X Slope (%)	0.2		X Walk 2 X Slope (%)	2.9
N/A	Ramp inside XWalk1?	Yes	N/A	Ramp inside XWalk2?	Yes
	Road Slope (%)	0.8	N/A	Clear Space?	N/A
	Road X Slope (%)	6.5	N/A	Clear Space to XWalk (in)	N/A
N/A	Any Obstructions?	N/A	N/A	Storm Grate/Utility Hazard?	N/A
	Obstruction Type		Į.	Storm Grate/Utility Type	
		N/A			N/A
			Yes	Surface Condition? (G/P)	Good
AND DESCRIPTION OF THE PERSON

Remove & Replace Curb Ramp With Two New Directional Ramps or Equivalent.

Not Found, R304.5.1, R304.2.2
