Access Compliance Report

Public Rights-of-Way (Curb Ramps)

Intersection ID: 5954	Main Street: PARSIFAL_LN	Cross Street: ATKINS_RIDGE_DR	Location: S
ADA ID: 611E363C32FC	Ramp Type: BlendTrans1	Initial Pass/Fail: Fail	Overall Compliance: No
Severity Score: 25			
Codes/Mitigation Info/Possible Solution		Field Measurements/Component Compliance

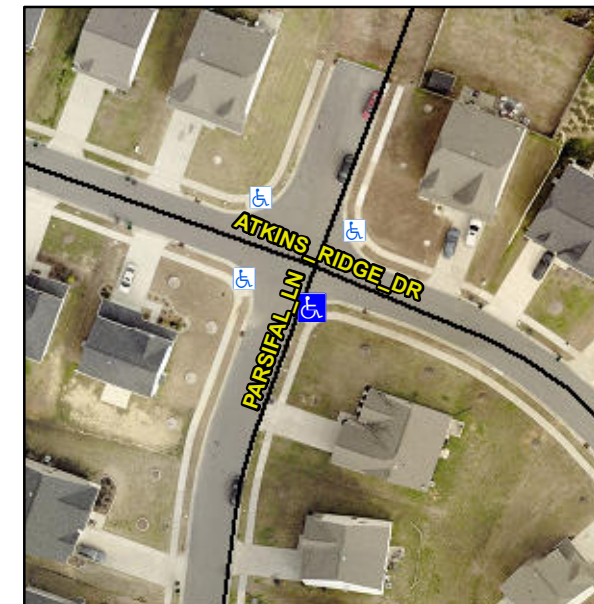
RP < 5%

Not Found, R304.5.3

Compliance	Description	Data	Compliance	Description	Data
N/A	Ramp Length (in)	47.0	Yes	BlendTrans Slope (%)	3.9
Yes	Ramp Width (in)	48.0	No	BlendTrans XSlope (%)	7.3
N/A	Flare Type LT	N/A	N/A	Flare Type RT	N/A
N/A	Flare Slope LT (%)	N/A	N/A	Flare Slope RT (%)	N/A
N/A	Flare Traversable LT?	N/A	N/A	Flare Traversable RT?	N/A
N/A	Landing Length (in)	N/A	N/A	DWS Provided?	N/A
N/A	Landing Width (in)	N/A	N/A	DWS Contrast?	N/A
N/A	Landing Slope (%)	N/A	N/A	DWS Length (in)	N/A
N/A	Landing X Slope (%)	N/A	N/A	DWS Full Width?	N/A
N/A	Landing Curb? (Y/N)	N/A	N/A	DWS Offset (in)	N/A
N/A	Shared Landing?	N/A			
N/A	Gutter Ponding?	N/A	N/A	Gutter Slope (%)	N/A
N/A	Gutter Lip Ht (in)	N/A	N/A	Gutter X Slope (%)	N/A
N/A	Painted X Walk1?	No	N/A	Painted X Walk2?	No
	X Walk 1 Direction	To NW		X Walk 2 Direction	To NE
	X Walk 1 Width (in)	N/A		X Walk 2 Width (in)	N/A
	X Walk 1 Slope (%)	3.2		X Walk 2 Slope (%)	4.9
	X Walk 1 X Slope (%)	7.9		X Walk 2 X Slope (%)	2.4

N/A	Ramp inside XWalk1?	N/A	N/A	Ramp inside XWalk2?	N/A
	Road Slope (%)	6.8		Clear Space?	N/A
	Road X Slope (%)	2.6	N/A	Clear Space to XWalk (in)	N/A
N/A	Any Obstructions?	N/A	N/A	Storm Grate/Utility Hazard?	N/A
	Obstruction Type			Storm Grate/Utility Type	
		N/A			N/A
			Yes	Surface Condition? (G/P)	Good
			No	Curb Slope (%)	22.4

Remove & Replace Curb Ramp With Two New Directional Ramps or Equivalent.
