# Access Compliance Report

## Public Rights-of-Way

### (Curb Ramps)

| Intersection ID: 43075 | Main Street: SCOTT_AV | Cross Street: ROMANY_RD | Location: W |

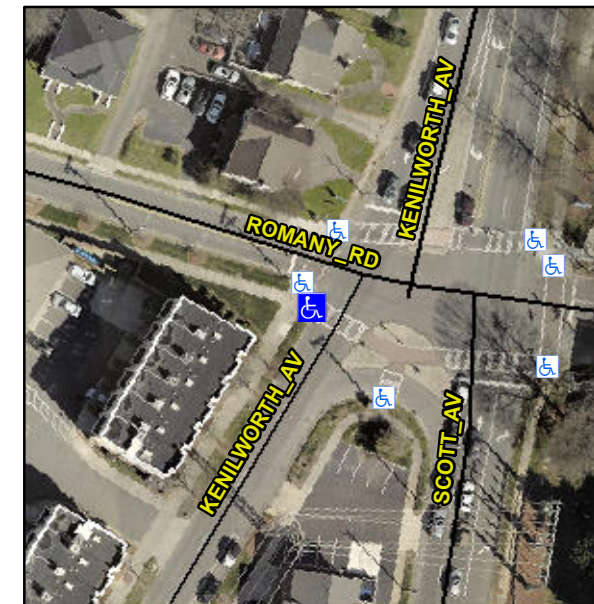
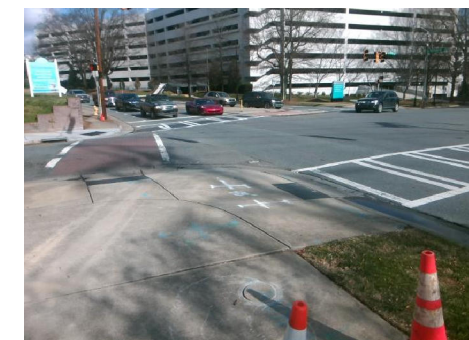
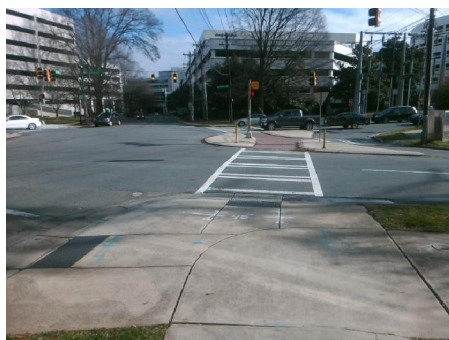
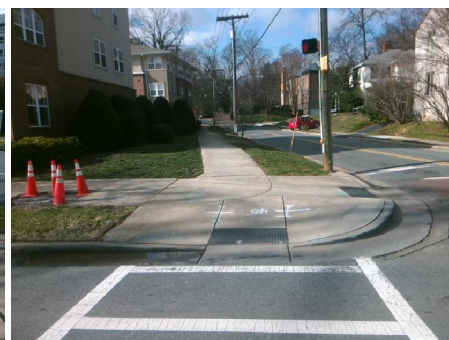
| ADA ID: 61343FF57A81 | Ramp Type: Perp | Initial Pass/Fail: Fail | Overall Compliance: No |
| | | | Severity Score: 21.25 |

**R304.5.1, R304.2.2**

| Compliance | Description | Data | Compliance | Description | Data |
|---|---|---|---|---|---|
| N/A | Ramp Length (in) | 89.0 | No | Ramp Slope (%) | 8.9 |
| No | Ramp Width (in) | 47.5 | Yes | Ramp XSlope (%) | 0.5 |

Possible Solutions:

**Remove & Replace Entire Ramp.**

Total Cost: \$ 1850.00
